EXECUTIVE DETERMINATION OF EMERGENCY, WAIVER FROM COMPETITIVE
PROCUREMENT REQUIREMENTS FOR THE BALLARD SIPHON REPLACEMENT IN
THE WASHINGTON SHIP CANAL

KING COUNTY
REPORT ON A
SONAR PROFILING SURVEY
BALLARD SIPHON
SEATTLE, WA

Subject: Ballard Siphon

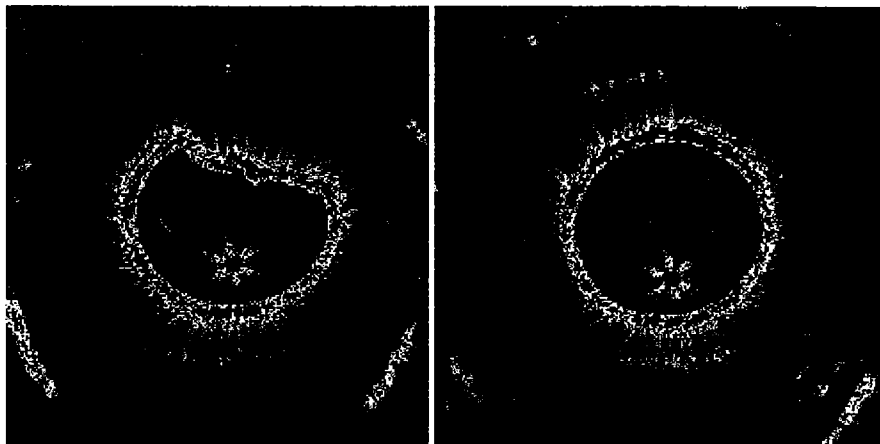
Distance: 103.9 feet

The north section of the siphons was dry to a chainage of 50 feet. The sonar data begins with a partially filled pipe from 55 feet to 70 feet. A number of features were noted in the traverse of the pipes. The most prominent of these is seen as in the west pipe data as cross-section change extending from 100 feet to 150 feet. This appears to be a crown incursion, possibly related to failure of the wood stave structure of the pipe crown. The onset of the fault is fairly abrupt at the 100 foot mark with a tapering of the effect to a minor cross-section change at a distance of 150 feet. A peak value of 17.9 percent obstruction of the pipe over the nominal 36 inch equivalent is measured. An example sonogram at 103.9 feet is contrasted below with a normal pipe section at a cable payout distance of 152.9 feet. In these images the probe position appears as a diffraction star just above the pipe invert.

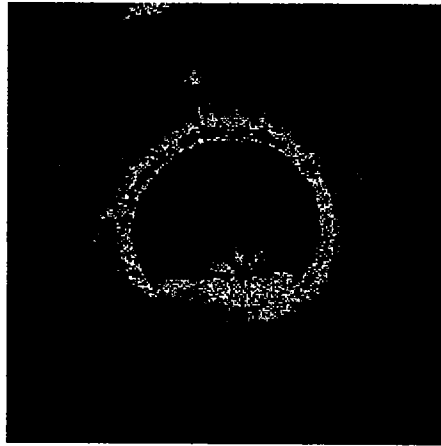
Distance: 152.9 feet

At a survey distances of 275 to 305 feet some sediment is detected, reaching a percent obstruction value of 10.8 percent. At the base of the descending section of the pipe a further deposit of debris is seen in the 425 to 480 range with a peak obstruction of 19.8 percent. An example sonogram showing the sediment at the pipe invert is shown below.

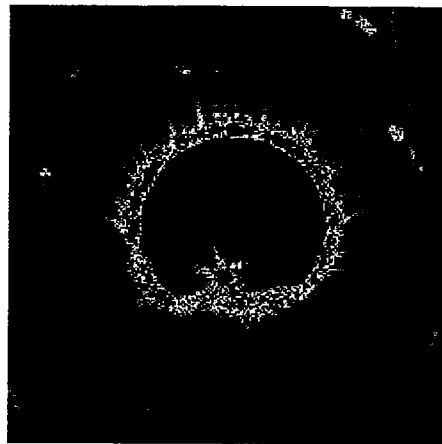
Distance: 1002.1 feet

The longest section of sediment or debris in the pipe is observed in the 750 to 1035 foot range, along the central area of the horizontal section. In this section of the siphon the percent obstruction is typically in the 15 percent range, with a peak values in the 18 percent range. A typical sonagram from this section is shown below.

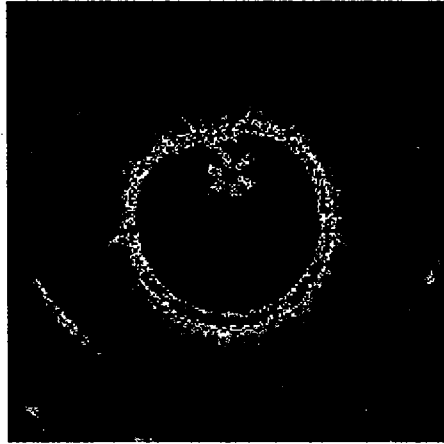
Distance: 1205.7 feet

Overall, based on a comparison with an ideal 36 inch pipe, the total obstructed area observed in the west siphon results in a calculated sediment volume of 834 cubic feet. South of the 1080 foot distance the siphon ascends at a steeper gradient to the south afterbay. Approximately mid-point in this ascending segment the siphon shows a more subtle cross-section change in the 1205 to 1220 foot range. An example of the data from this area is displayed as follows.

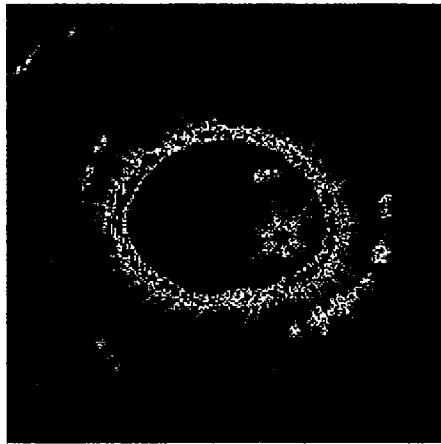
Distance: 128.7 feet

The east siphon shows similar variations to those observed in the west siphon. A section of the siphon from 115 to 210, overlapping the west pipe defect interval of 100 to 150 feet, shows changes in cross-section that are not nearly as pronounced as those of the west siphon. The siphon does not show the crown effects seen in the west pipe, but rather exhibits an oblate shape with the spring-line diameter slightly larger than the nominal 36 inch dimension. An example of the oblate east pipe is shown in the following image.

- Approximately 95 feet of pipe (East Pipe Sonar Images 115 to 210) indicate pronounced changes "squashing" of the pipe shape but do indicate a breach in the pipe wall.
- Approximately 130 feet of pipe (East Pipe Sonar Images 770 to 900) indicate noticeable changes in shape with an apparent discontinuity in the pipe wall. This discontinuity might involve a breach in the pipe wall at the springline for approximately 30 feet (particularly noticeable in images 770 to 800)
- Approximately 15 feet of pipe (East Pipe Sonar Images 1195 to 1210) show less pronounced changes in shape.
- The calculated volume of debris in the East Siphon is 551 cubic feet.

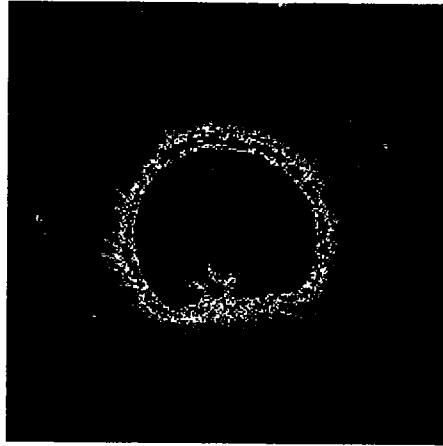
Distance: 800.1 feet

The central horizontal run in the east siphon shows some debris accumulation, but at reduced levels as compared to the west pipe. This may be due to the role of the east siphon in carrying only peak flows. The total obstructed area calculated sediment volume is 551 cubic feet for the east siphon. This is approximately 35% less than the west pipe. An example of the central sedimented zone is shown in the following sonogram.

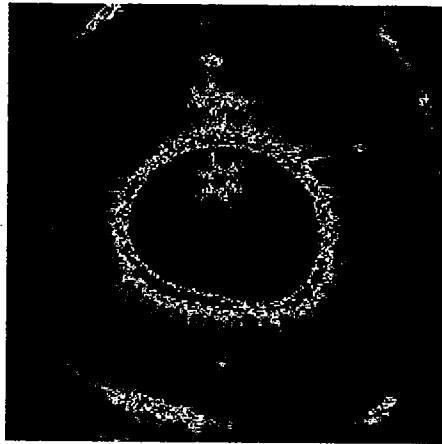
Distance: 1203.2 feet

Finally, a limited section of subtle cross-section change is observed that is coincident with a similar feature on the west siphon. Located in the range of 1195 to 1210 feet this zone is illustrated in the following image.

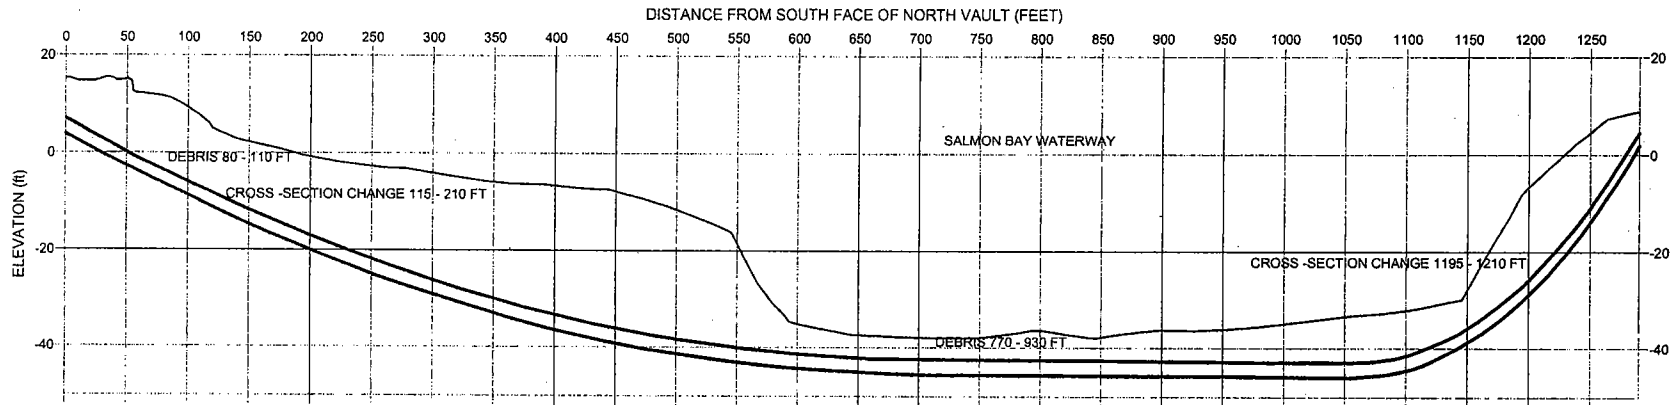
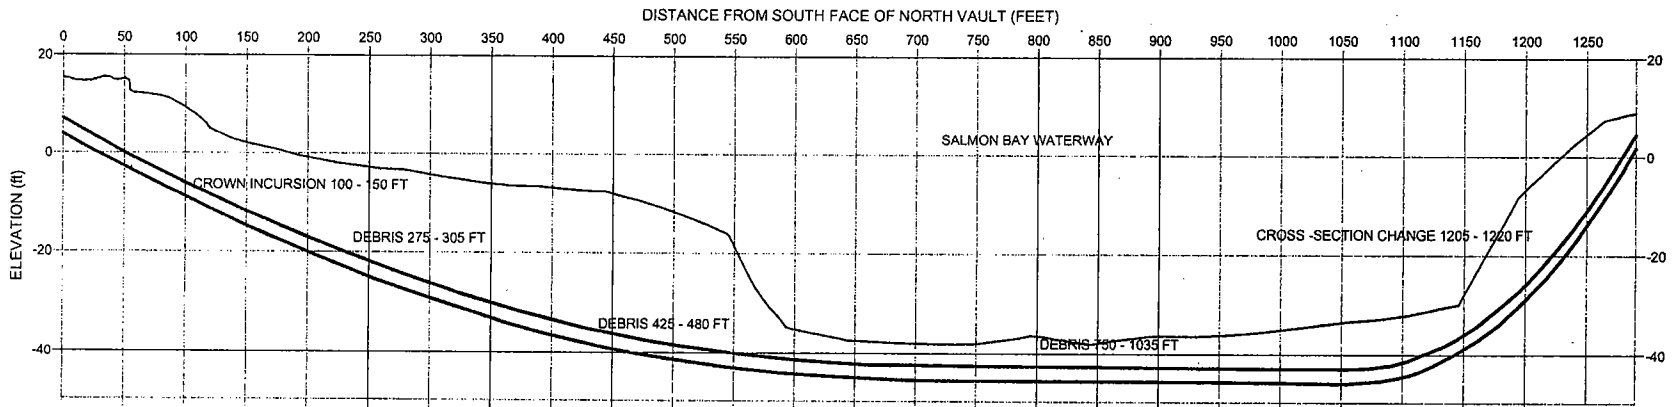
KING COUNTY BALLARD SIPHON	
SEWER INSPECTION SURVEY	
BALLARD WOOD STAVE PIPES LONGITUDINAL SECTIONS	
FRONTIER GEOSCIENCES INC.	
DATE: NOV 2005	DWG: B-LONG-1

The processed sonar data for the west siphon is plotted in cross-section format on Drawings BW-SEC-1 to BW-SEC-5 for the west pipe and Drawings BE-SEC-1 to BE-SEC-5 for the east pipe, at a scale of 1 inch = 2.5 feet. As the traverse of the pipes was carried out with increasing station chainage to the south, the cross-sections are plotted looking south. These observed data is displayed as a red line, with a black circle indicating the nominal pipe section for comparison. The chainage zero was defined as the south face of the entry vault. The longitudinal section for the siphons is plotted on Drawing B-LONG-1.

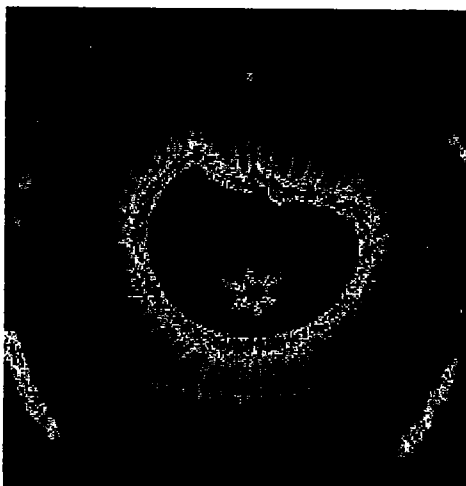
- Approximately 50 feet of pipe (West Pipe Sonar Images 100 to 150) indicate pronounced changes of the pipe shape. Approximately 10 feet (West Pipe Sonar Images 115 to 125) indicate a probable breach in the crown of the pipe. The following image, taken at 104 feet into the pipe, is representative of the changes in the pipe shape.

Based a visual assessment of the sonar data plots, it's my opinion that the areas that I discussed in the **Sonar Image Evaluations** have approached and, in some areas, exceeded the 5% out-of-roundness criteria. Of more concern are those areas where pipe wall breaches are suspected. Continuing and possibly abrupt loss of pipe integrity are possible in the regions where the pipe walls have buckled. Even if the pipe does not collapse, the water tightness of the pipe is most certainly lost as the joints between the wood staves have failed. Depending on the difference in pressure between the ship canal water and the pressure head in the siphon, water could be flowing into or out of the siphon through these breaches. The fact that the west siphon has 51% more calculated debris volume than the east siphon might be attributed to material entering the pipe through pipe wall breaches which appear to be more pronounced in the west pipe than the east pipe.

I think it's reasonable to conclude that the pipes have exceeded their service lives and are failing at multiple locations. Repair or replacement are necessary to ensure that total collapse of the pipe in those areas where the crown has failed, does not occur. Careful consideration must be given to the method of repair selected. I caution against the obvious repair methods of pipe bursting or slip lining due to the fact that the out-of-roundness of the pipes will result in substantial forces being applied to the pipe as the slip lining is dragged through. These large forces could precipitate a pipe failure during the repair activities. This concern is compounded by the fact that figure 8 shaped steel bands are used to strap the pipes together, the bands being spaced at 15 feet on center over the length of the pipes. Loads imposed on one siphon during slip lining could be transmitted to the other siphon through these figure 8 steel bands causing crushing or buckling in the pipe that wasn't in the process of being repaired.
