**Sol Duc River drowning, Nov. 13, 2006 at Highway 101 bridge west of Sappho.
WSDOT Bridge 101/314 at milepost 203.15.**

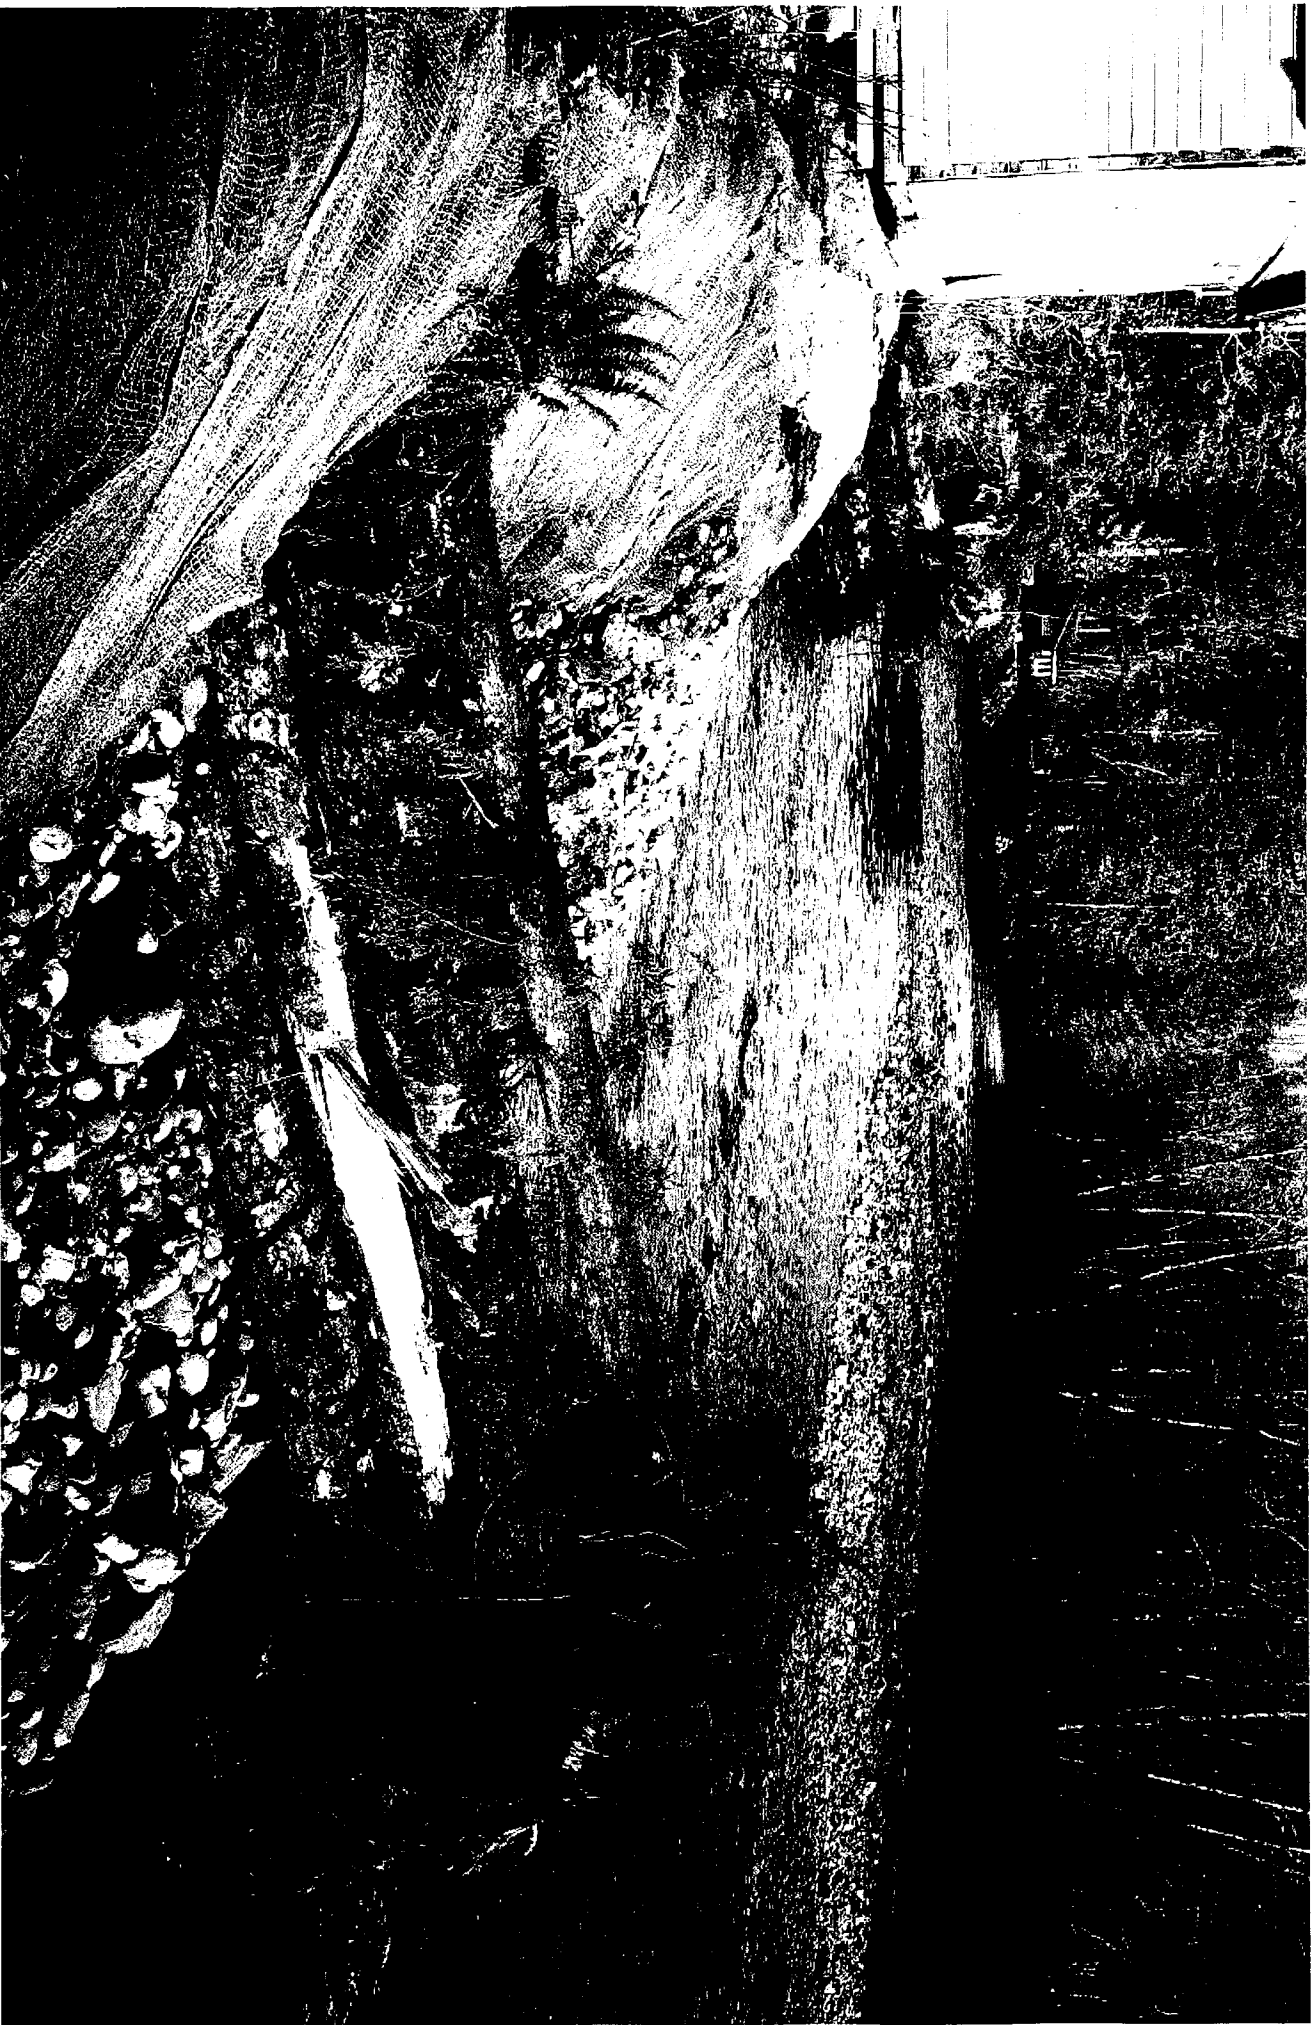
South Fork, Snoqualmie River

The current at the outside bend of a river will sweep people and debris in the water toward this DDES approved project.

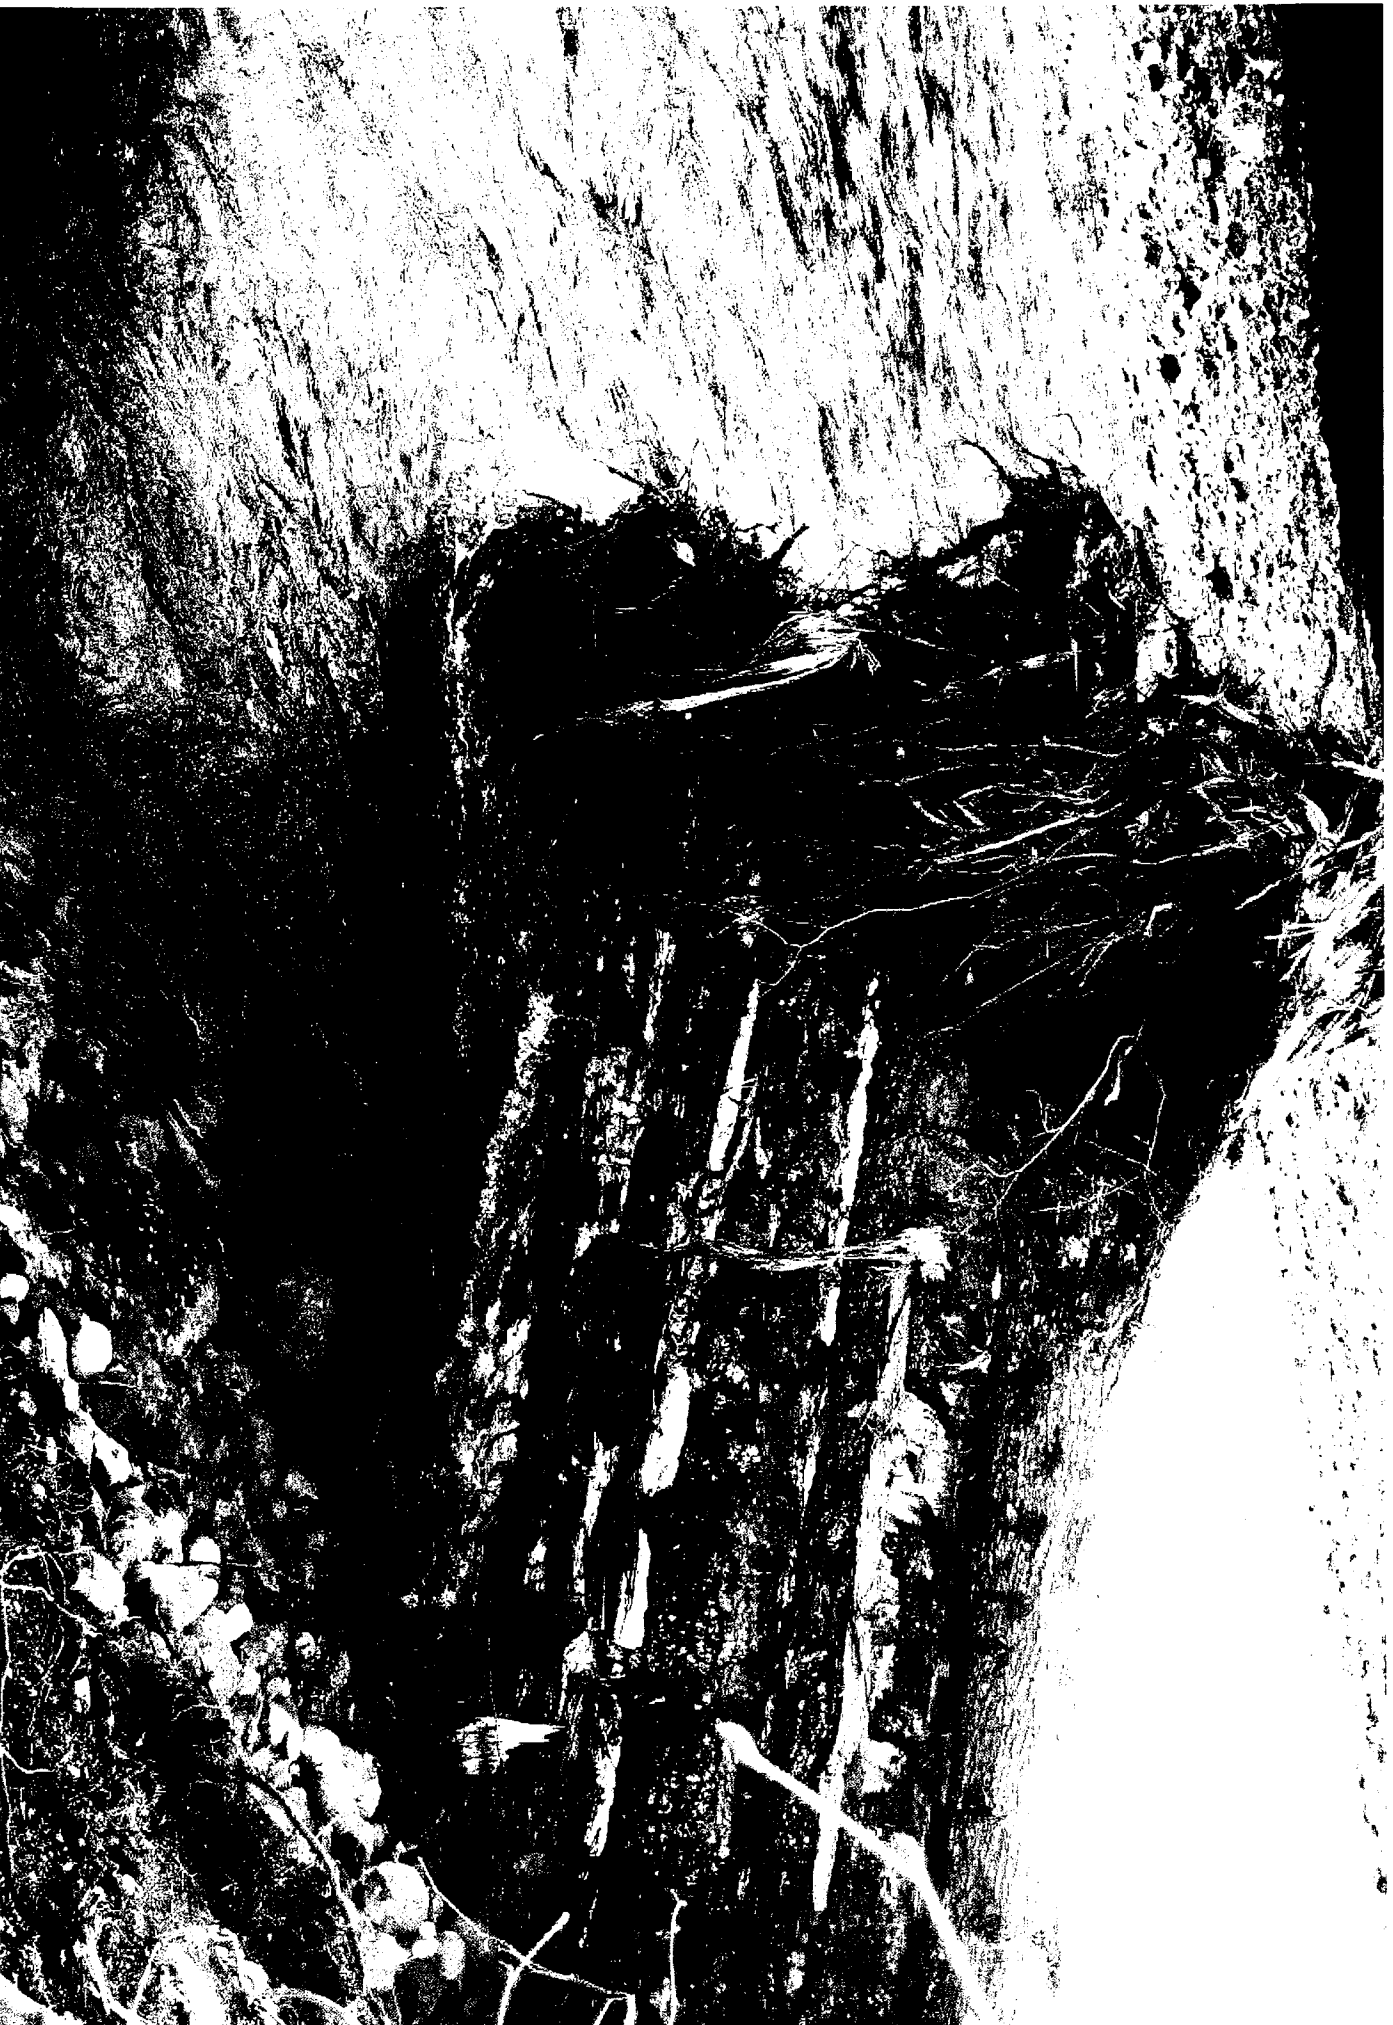
South Fork, Snoqualmie River

Close up of the sieve created by a LWD project (low water view).

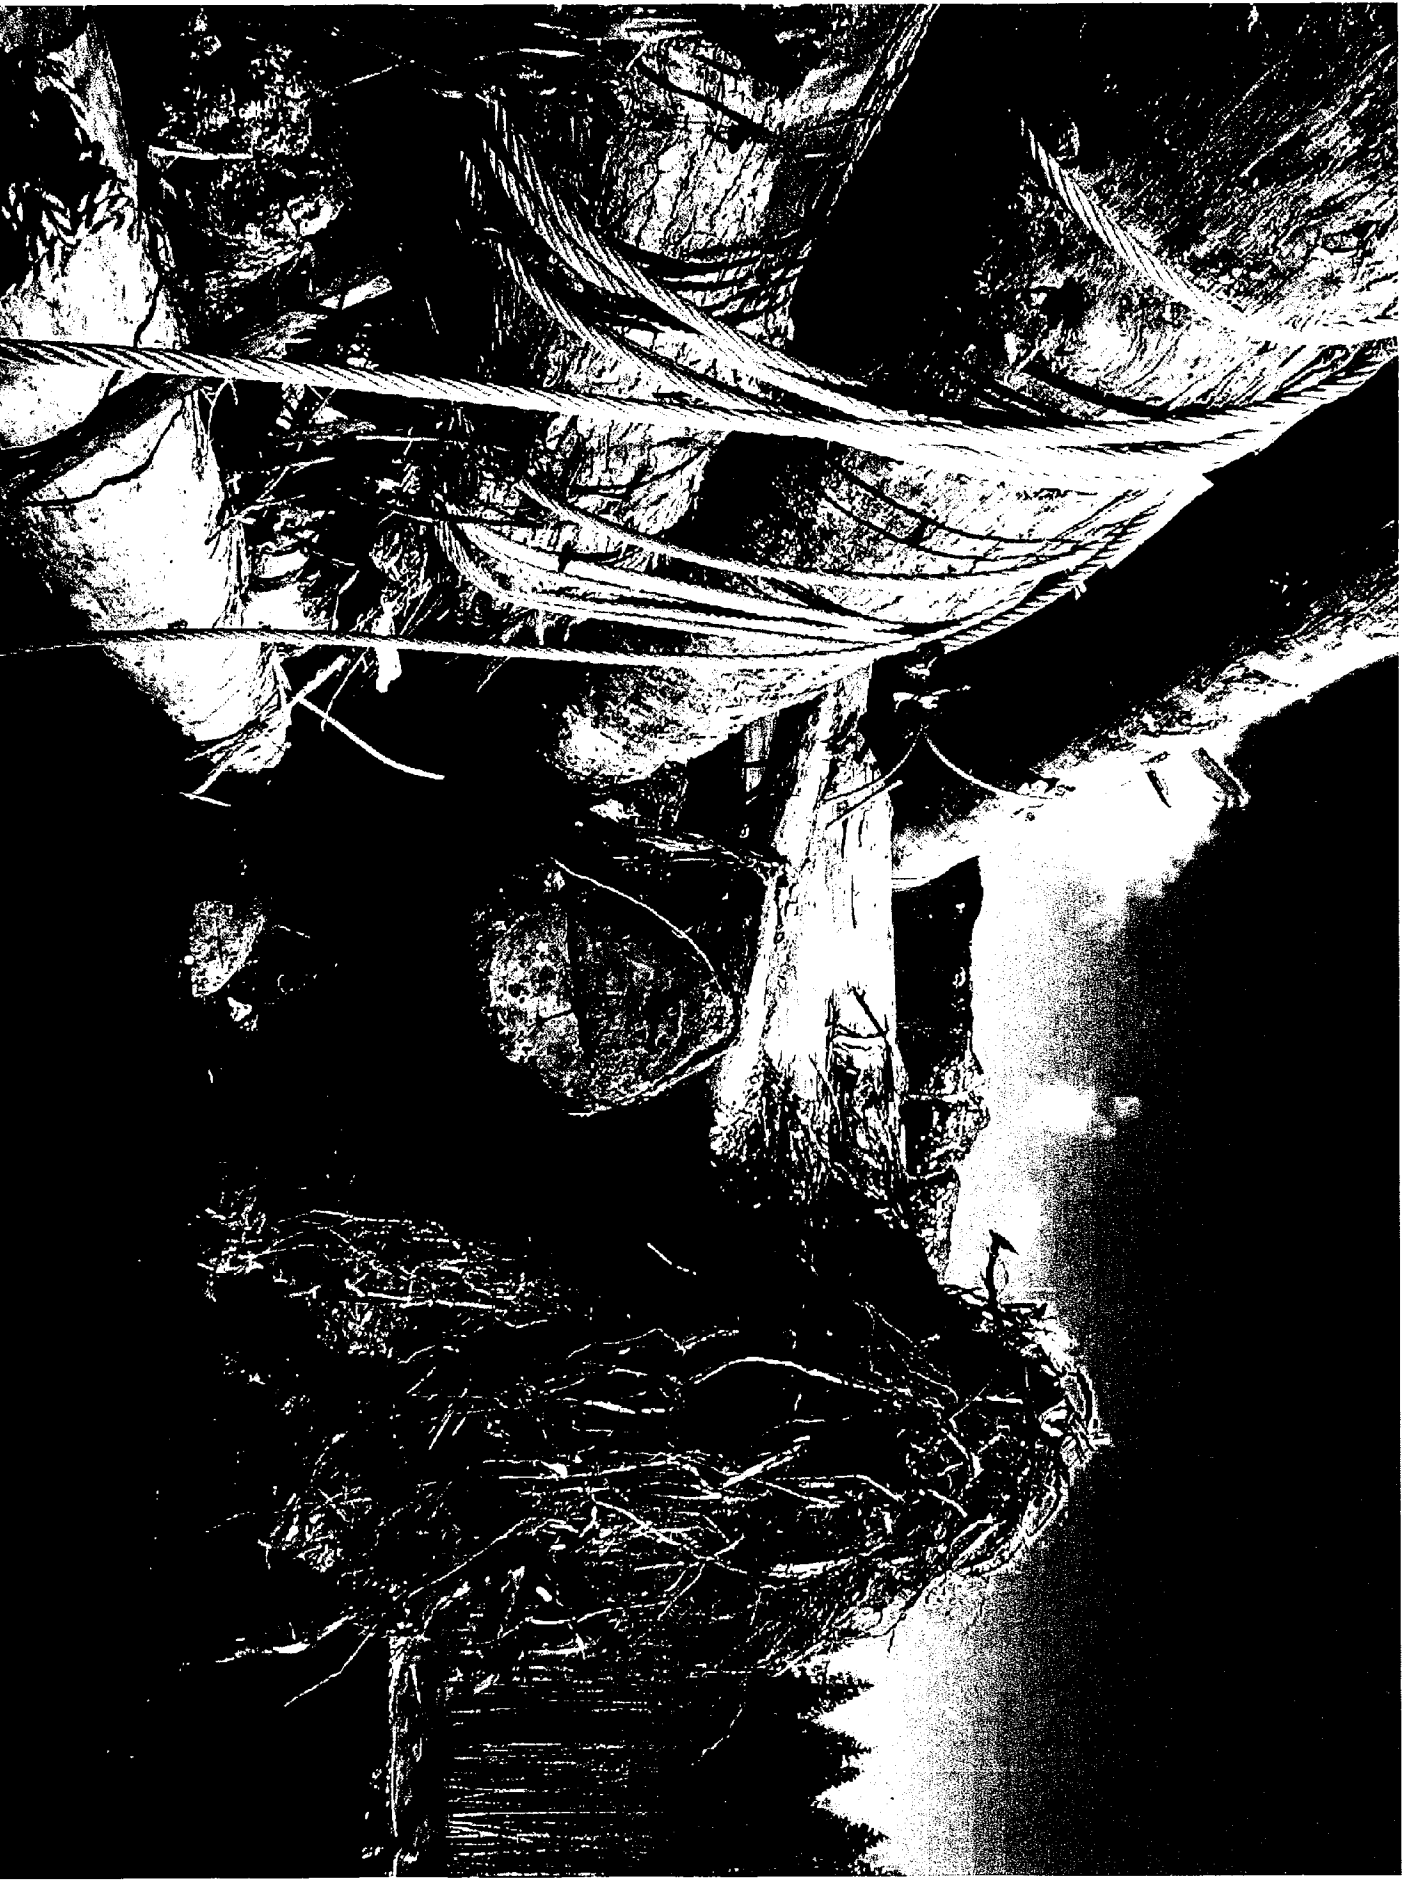
North Fork, Stillaguamish

Large cables are commonly used to secure wood projects.

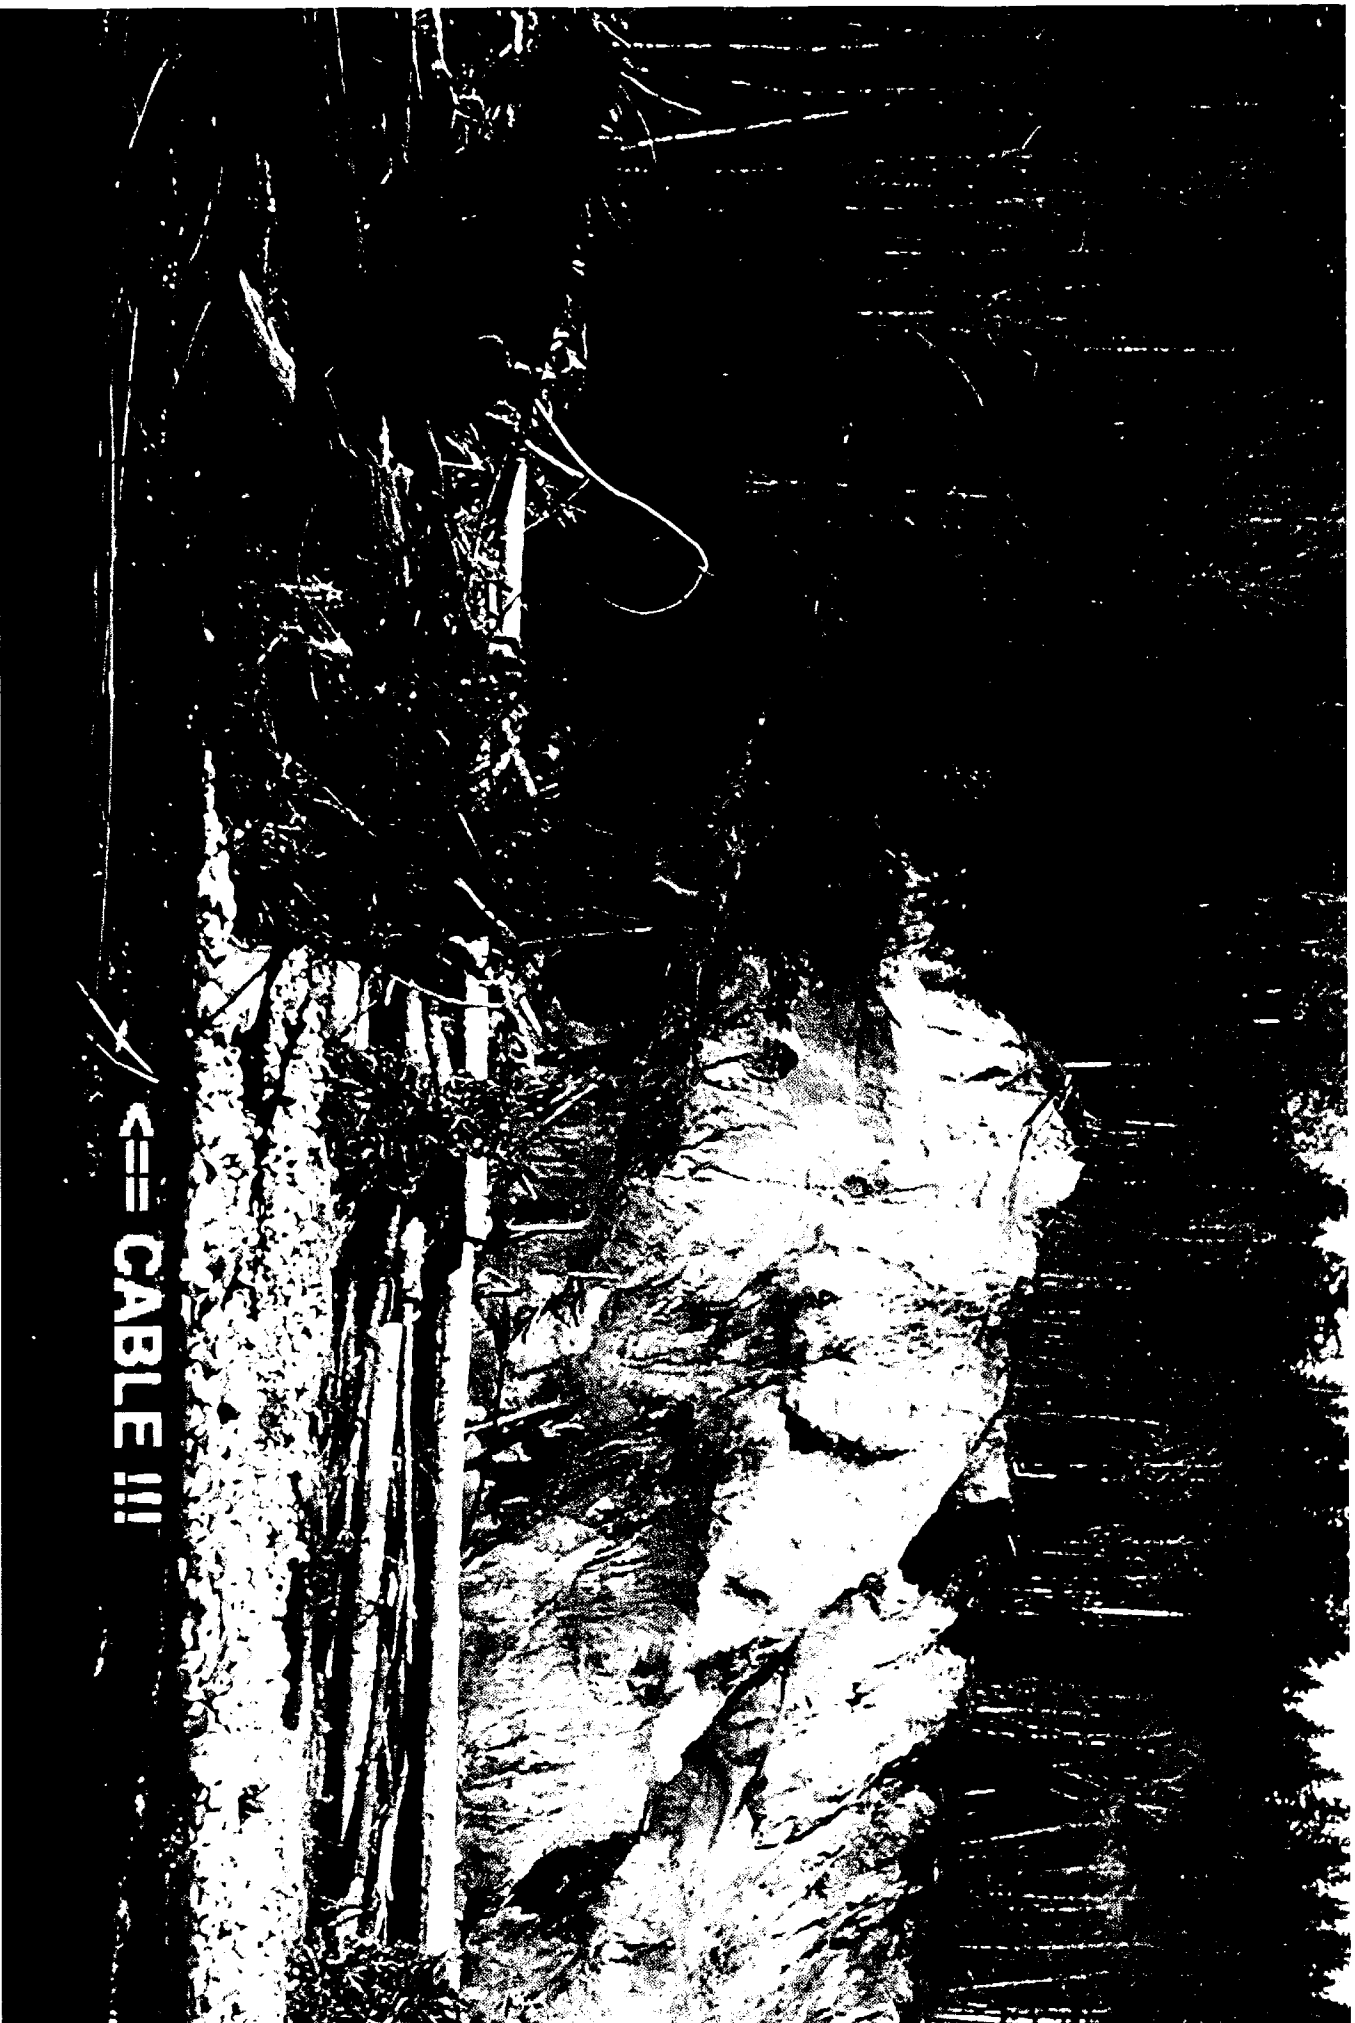
North Fork, Stillaguamish
This failed cable now spans the main channel at a level that will knock over and potentially entangle anyone floating the river.

←== CABLE !!
