Baring Bridge #509A

Baring Bridge Emergency Action

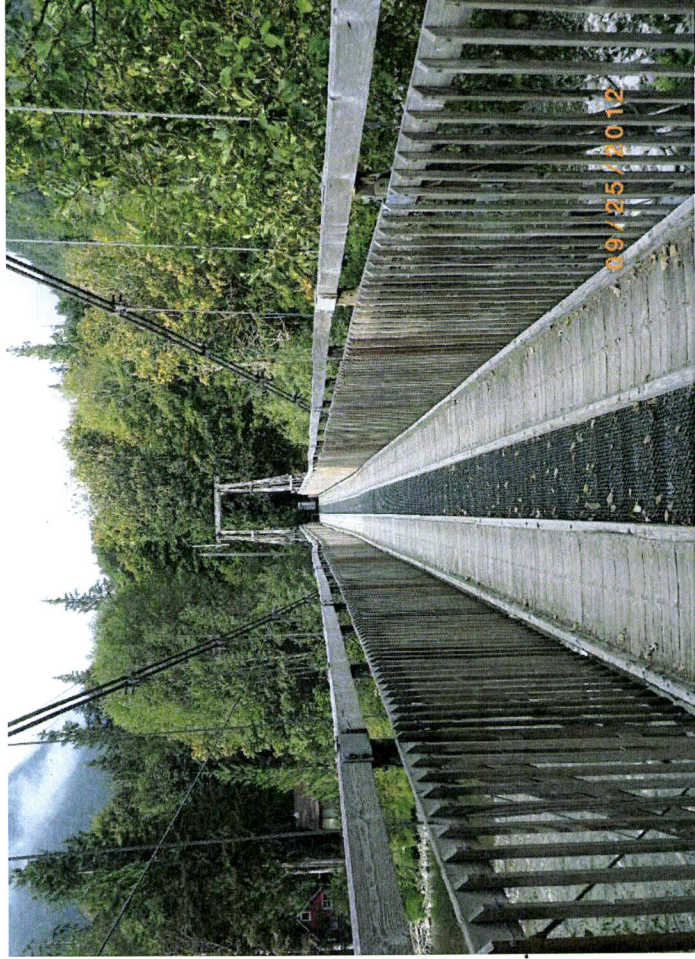
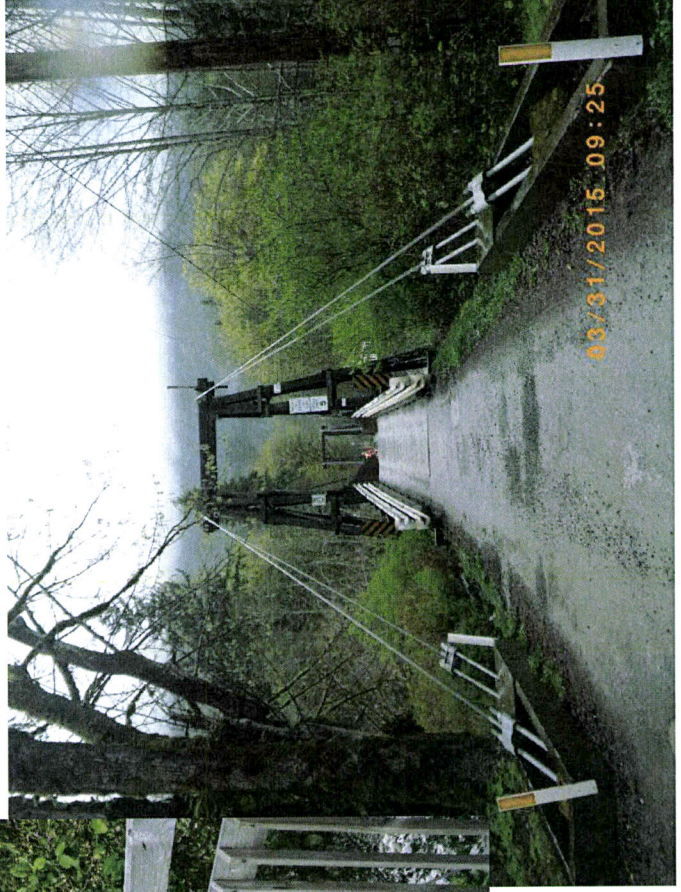
Many floor beams have splits and cracks: Need repairs

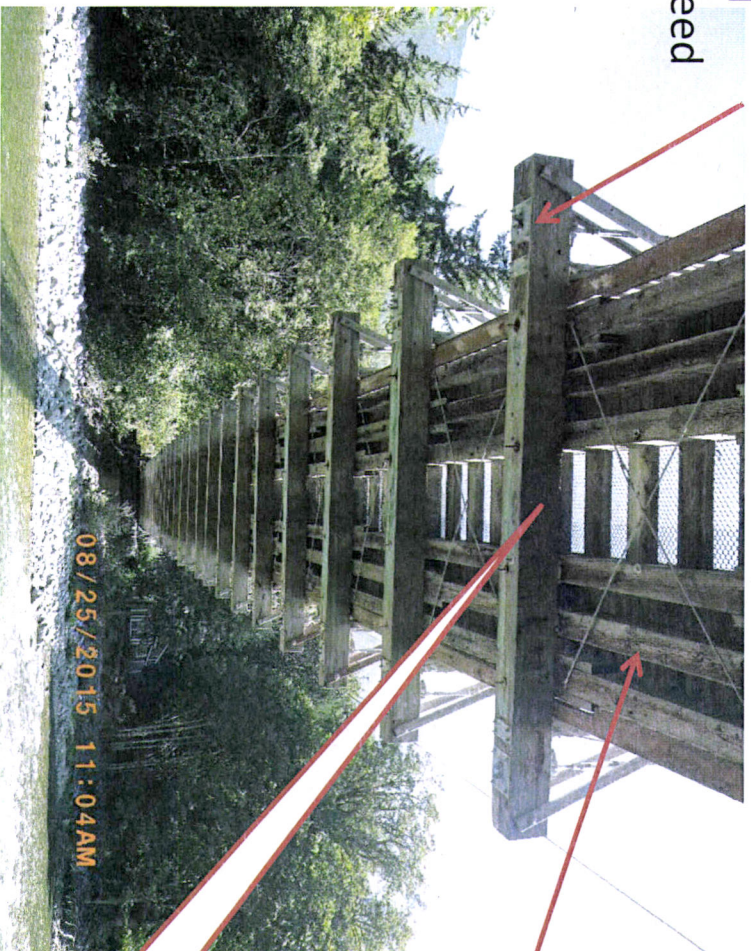
All stringers were sounded and drilled at two different locations on the main span. More than 40% of these stringers were found very soft at top and bottom. Some have splits or crushing

All deck planks worn $\frac{1}{2}$ " to 1" deep on wheel lines and fasteners are loose
