**MEDTOX – HERRERA HAZMAT SURVEY 2010**

## HAZARDOUS BUILDING MATERIALS SURVEY

Alder Wing and Alder Tower, Youth  
Services Center  
1211 East Alder Street  
Seattle, Washington 98122

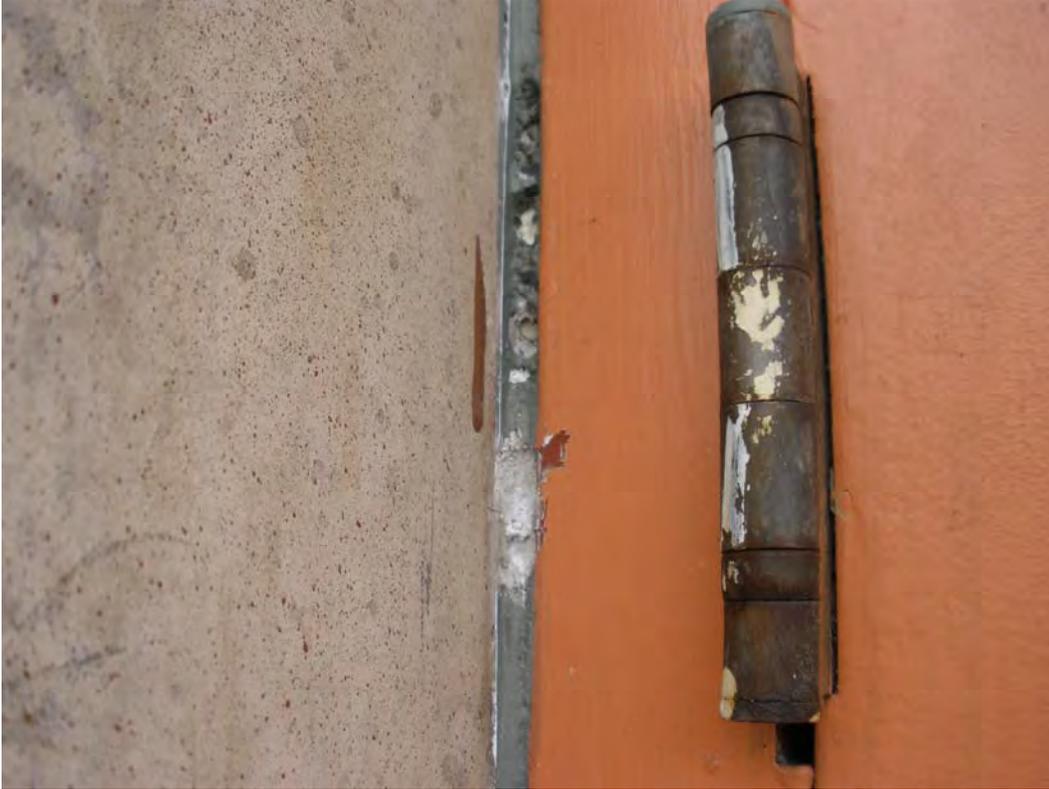
- **Gray chalky door caulk (HM12)**. This material is located around Door 26 and other doors of the Alder Wing. Two samples were collected for asbestos content; this material was found to contain 3-4% Chrysotile asbestos.

Photo 13. ACM gray chalky door caulk - Alder Wing.

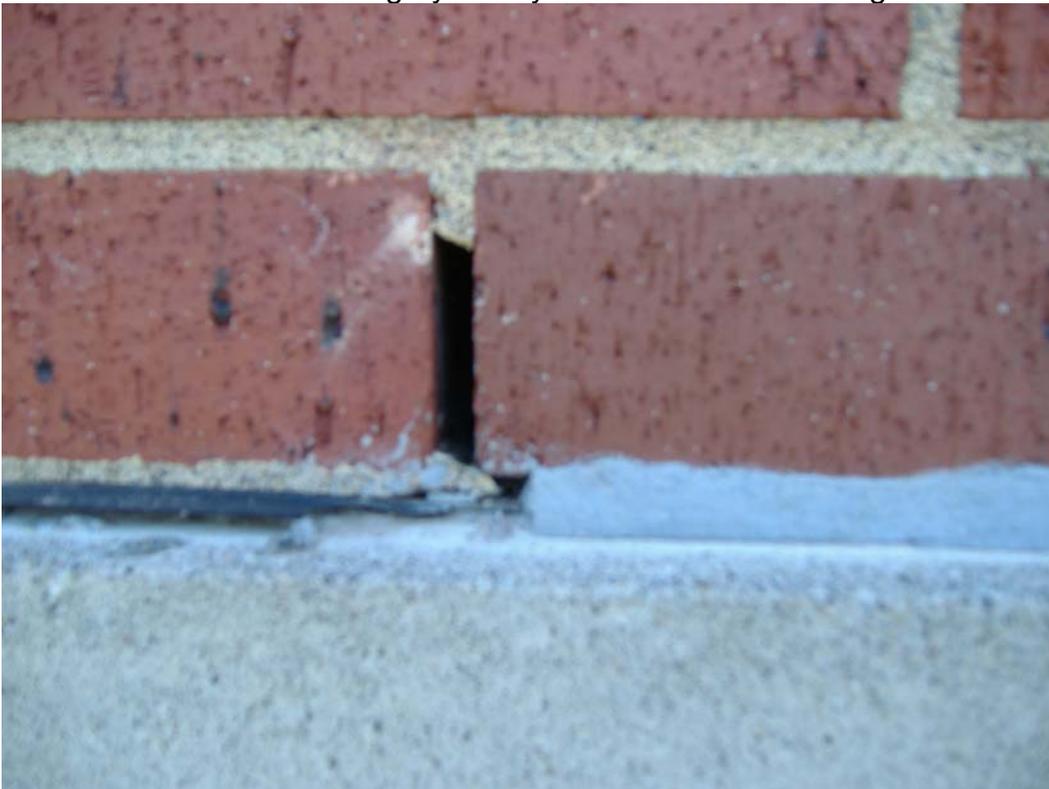
- **Gray grout with vapor barrier (HM2)**. This material is located between the brick and concrete walls on the exterior of the Alder Wing. Three samples were collected for asbestos content; no asbestos was found in the grout. The vapor barrier was found to contain 5% Chrysotile asbestos.

Photo 14. Gray grout with ACM vapor barrier paper (brick to concrete)

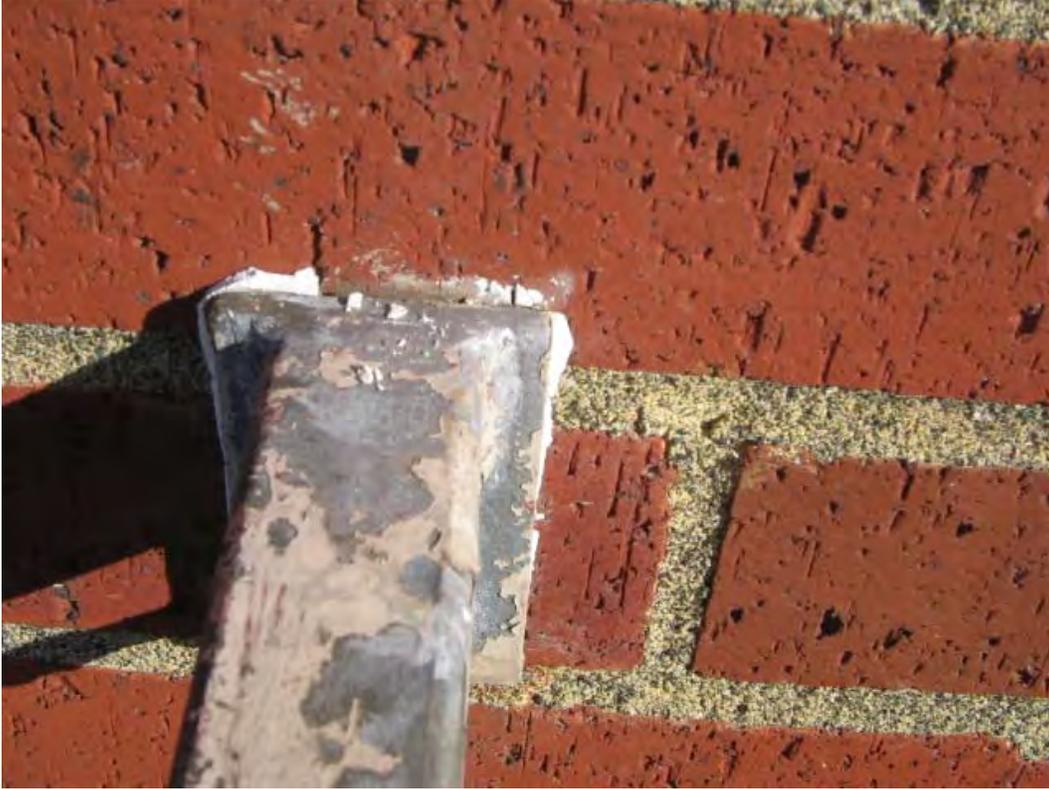
- **White caulking (HM7)**. This material is located on the south side, second floor exterior brick wall where the stair rail meets the brick wall. One sample was collected for asbestos content; this material was found to contain 2% Chrysotile asbestos.

Photo 15. Brick mortar and ACM white rail-to-brick caulking-East Alder wing

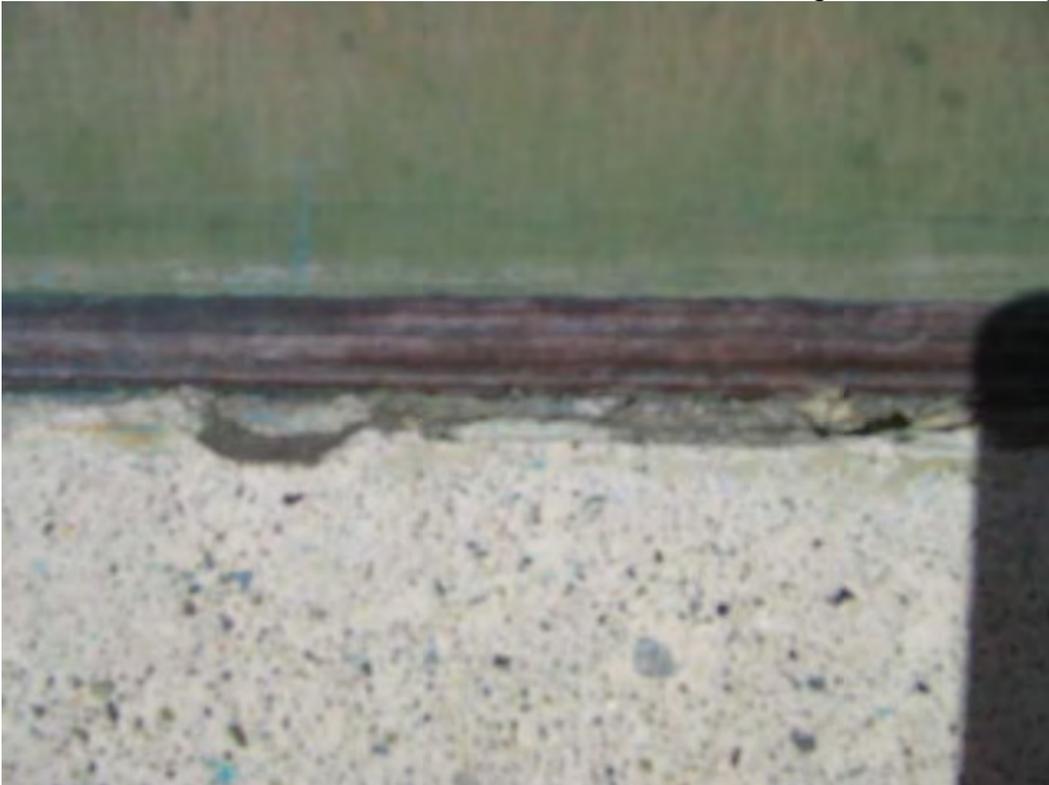
- Hard brown window caulk (HM16). This material is located on the windows. Two samples were collected for asbestos content; no asbestos was detected.
- **Gray window sealant (HM17)**. This material is located between the concrete wall and metal on the windows. Two samples were collected for asbestos content; this material was found to contain 5% Chrysotile asbestos.

Photo 16. ACM gray window glazing (between concrete and metal) on various exterior Alder wing windows

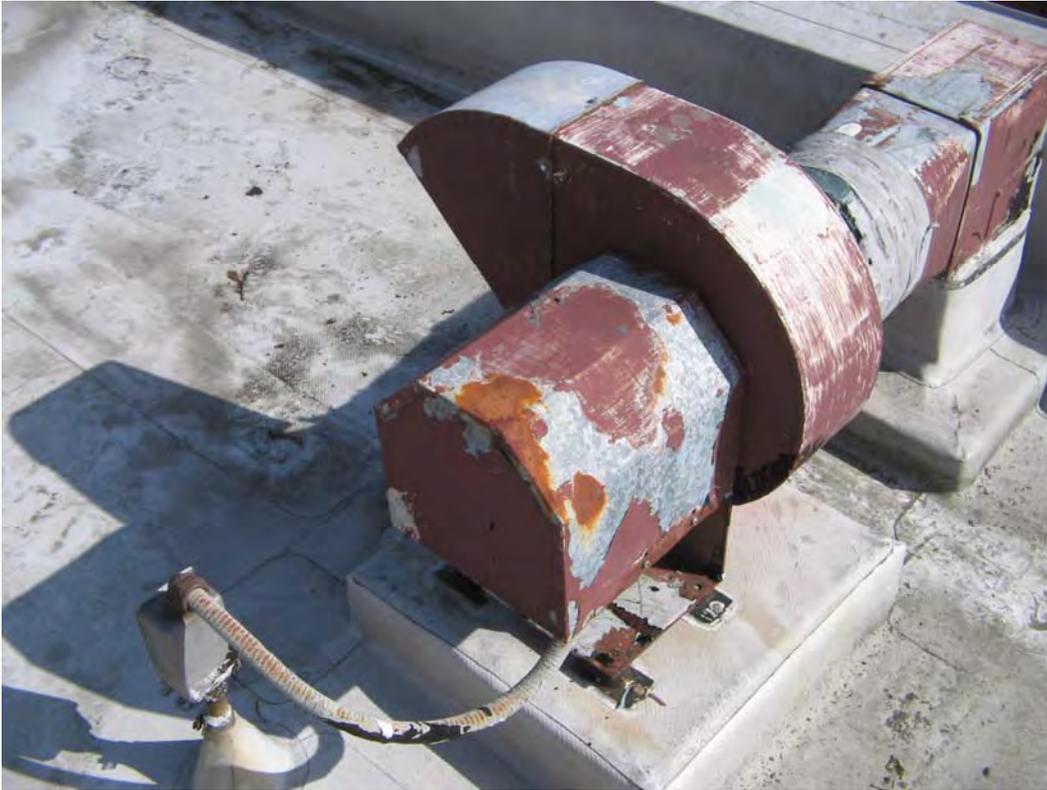
- **Silver roof coat (HM27)**. This remnant material is located on the southeast corner of the boiler roof and on the reddish brown vent on the roof south of the chiller system. Two samples were collected for asbestos content; this material was found to contain 3% Chrysotile asbestos.

Photo 17. ACM silver paint on reddish brown vent on roof-Alder Tower

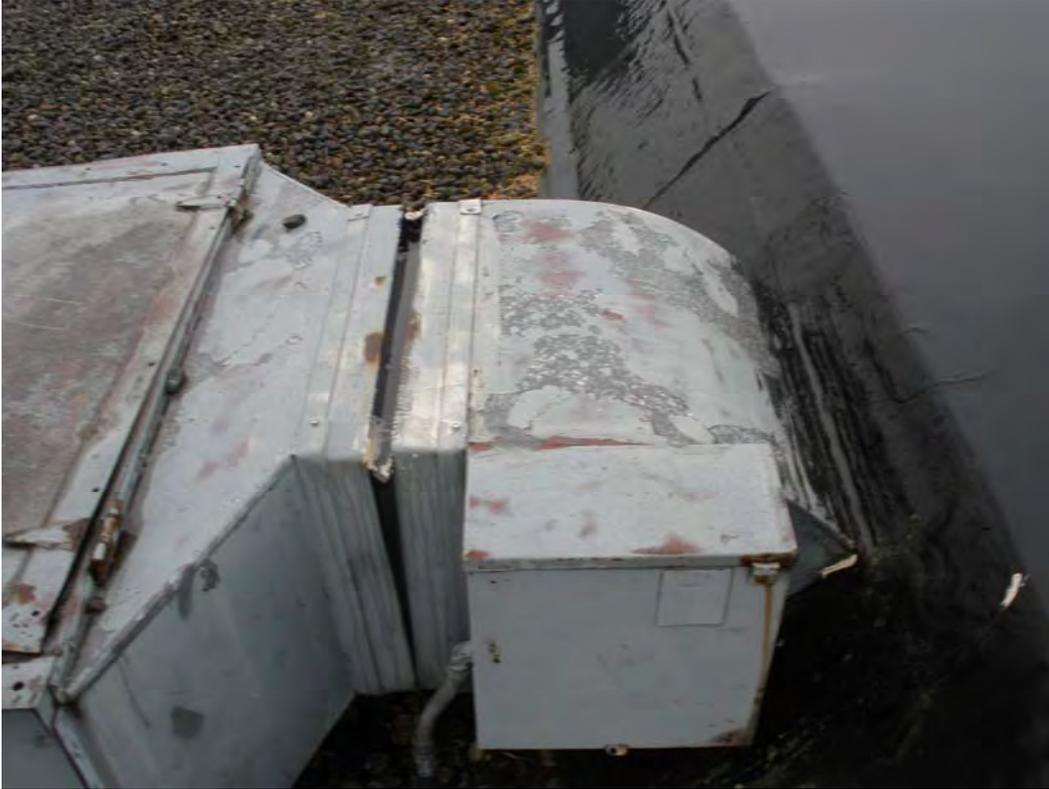
- **Exhaust duct sealant (HM21)**. This material is located on the exhaust ducts on the roof. Two samples were collected for asbestos content; this material was found to contain 2% Chrysotile asbestos.

- **Vent seam sealant (HM22)**. This material is located around the wall vents of the penthouses. One sample was collected for asbestos content; this material was found to contain 2% Chrysotile asbestos.

- **Vent caulk (HM23)**. This material is located around the wall vents of the penthouses. One sample was collected for asbestos content; this material was found to contain 2% Chrysotile asbestos.

Photo 19. ACM exhaust duct sealant, vent seam sealant, and vent caulk, Alder Wing roof

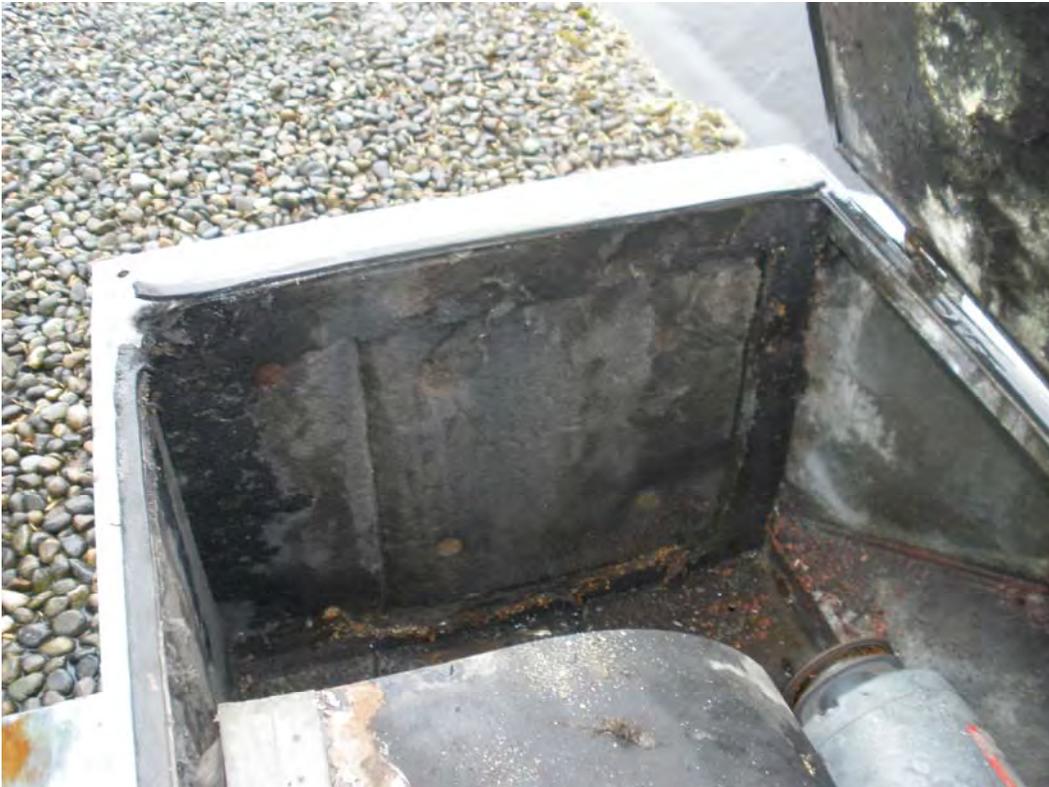
- **White sealant (HM25)**. This material is located on the vent cap/hatch areas on the roof. Three samples were collected for asbestos content; this material was found to contain 3% Chrysotile asbestos.

Photo 20. ACM white sealant on vent hatch

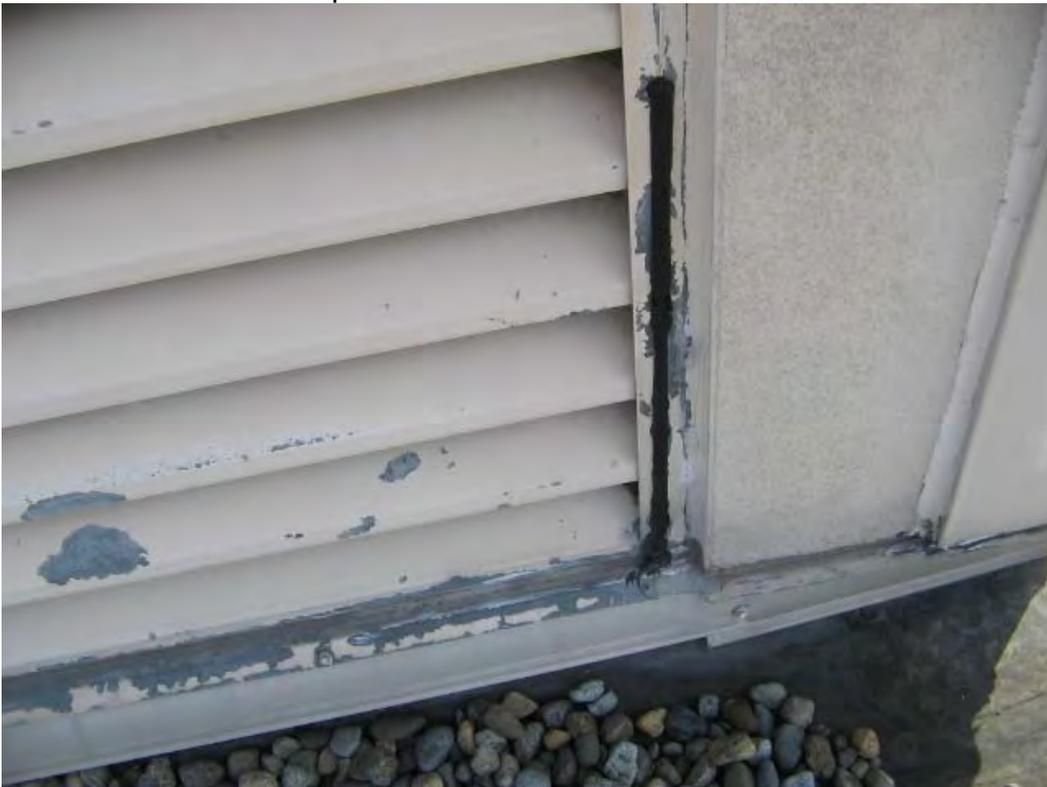
- **Brittle gray wall vent sealant (HM37)**. This material is located on the wall vent of the north penthouse. One sample was collected for asbestos content; this material was found to contain 2% Chrysotile asbestos.

Photo 22. North penthouse of Alder Tower, south wall vent sealants (thin beige and ACM brittle sealant)

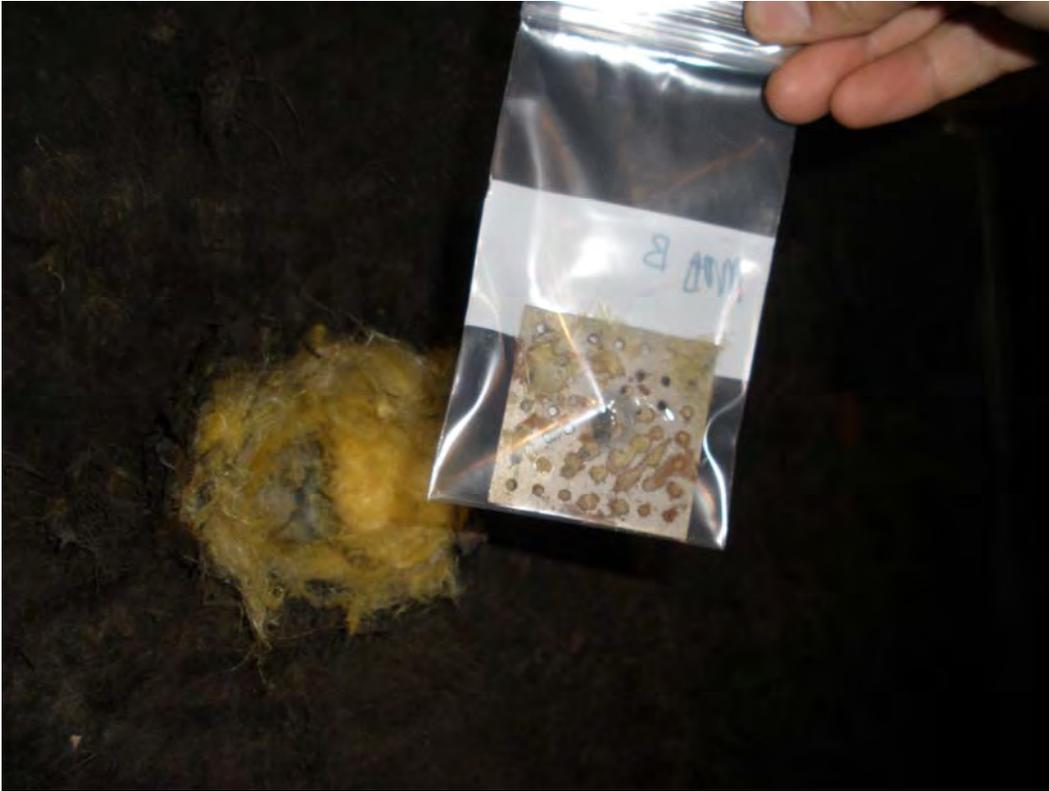
- **Stick pin adhesive (HM59)**. This material is located behind fiberglass insulation on doors and walls in the mechanical room B, C, and D on the second floor and also in the mechanical rooms on the roof (penthouses). Five samples were collected for asbestos content; this material was found to contain 5% Chrysotile asbestos.

Photo 23. ACM stick pin adhesive on mechanical room door-Alder Wing

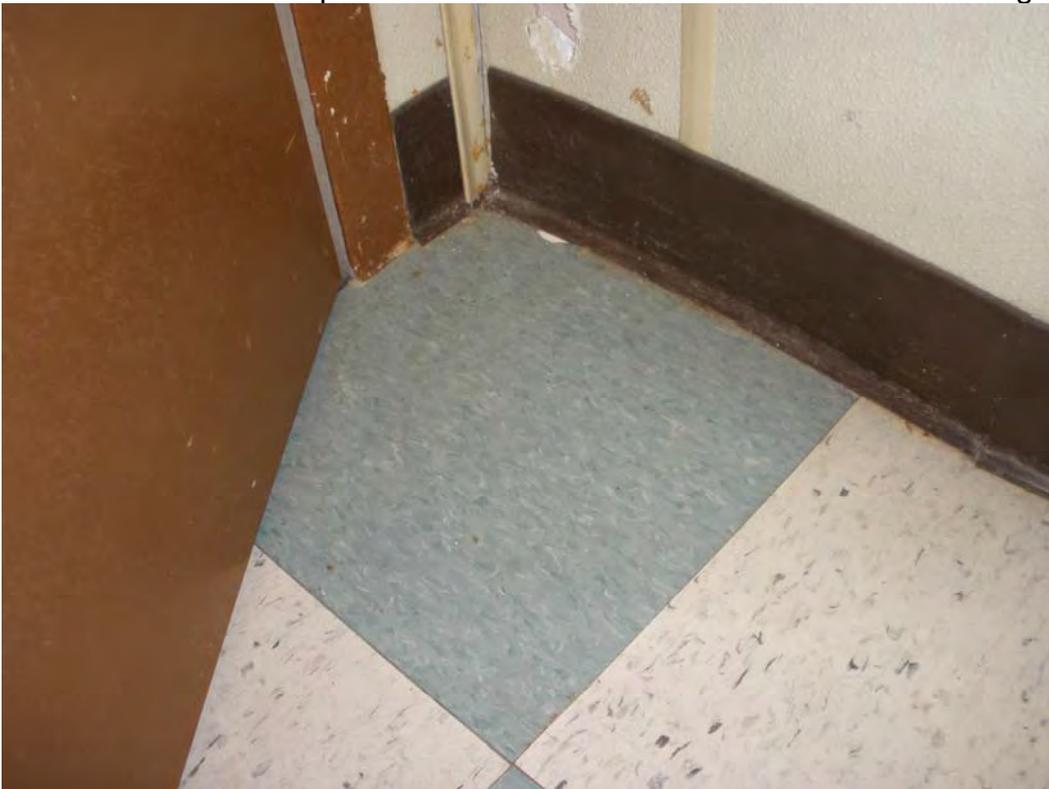
- **Bottom layer floor tile-beige (HM85)**. This 12- x 12-inch vinyl floor tile material is located in the gym restroom. One sample was collected for asbestos content; the floor tile was found not to contain asbestos, but the black mastic was found to contain 3% Chrysotile asbestos.

Photo 24. ACM black mastic under 2<sup>nd</sup> layer beige floor tile-Gym restroom Alder Wing

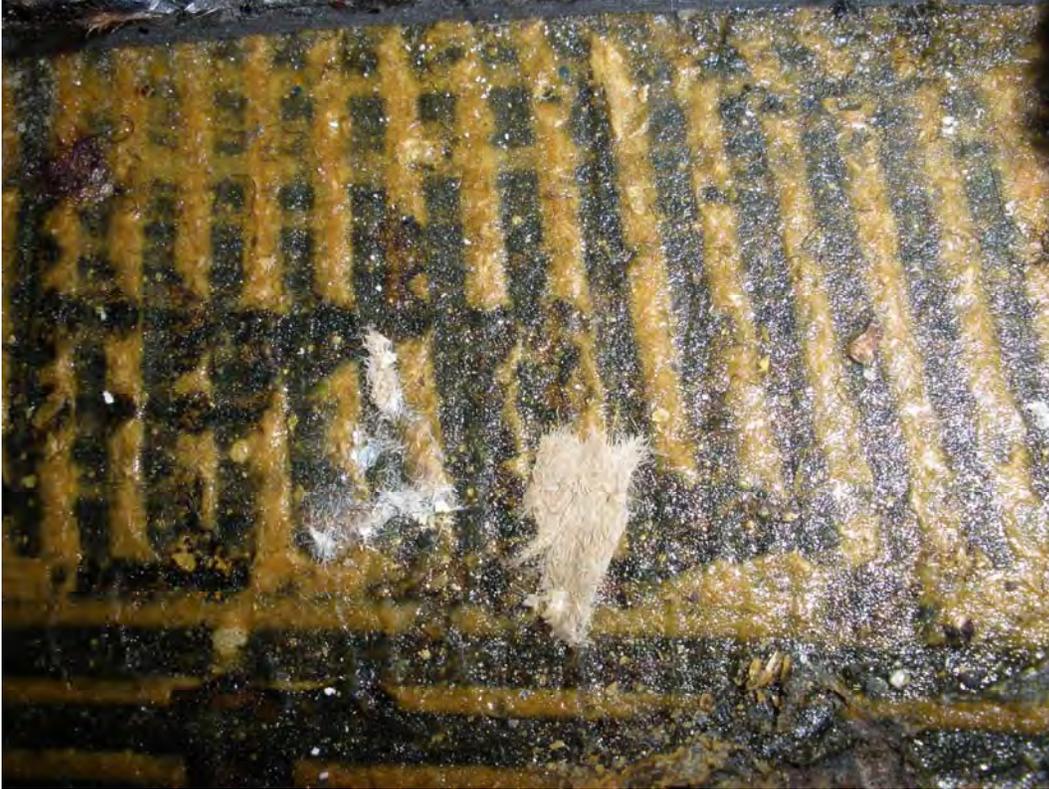
- **Yellow carpet adhesive (HM95)**. This material is located under the carpet in the hallway. One sample was collected for asbestos content; the black residual mastic found with the yellow mastic was found to contain 3% Chrysotile asbestos however, the yellow carpet mastic did not contain asbestos.

Photo 25. ACM black residual mastic under yellow carpet mastic- 1<sup>st</sup> floor Alder Tower

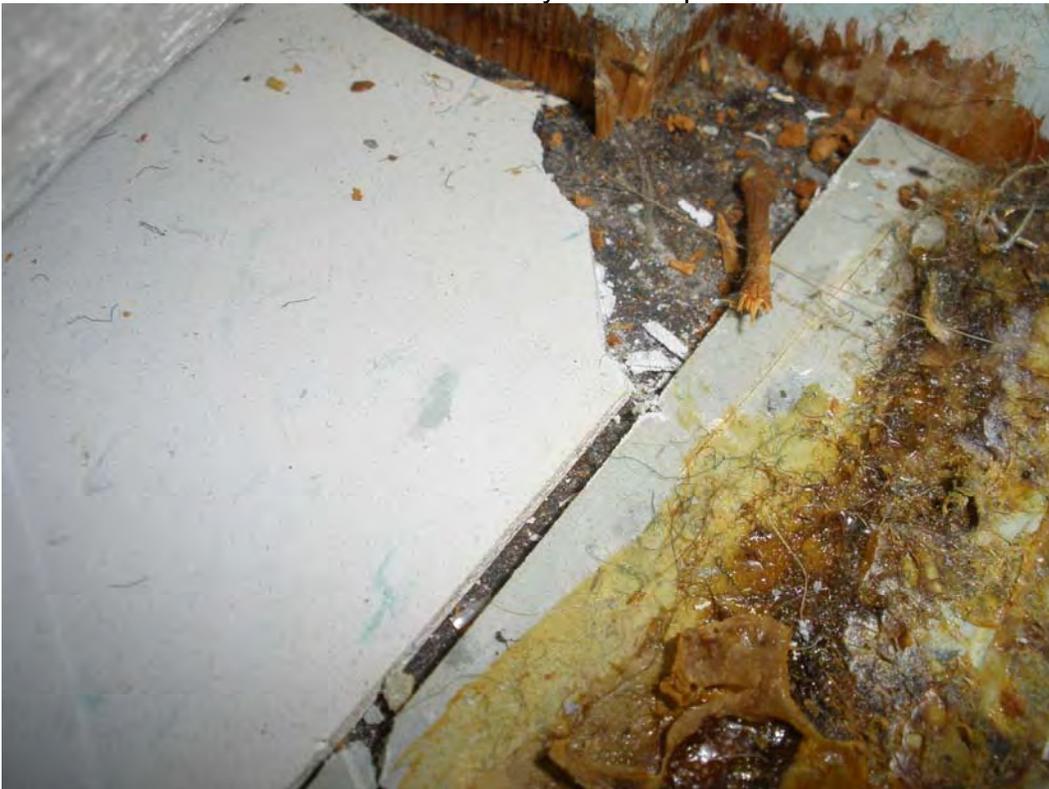
- **White with green streaks 12- x 12-inch floor tile and black mastic under carpet (HM102).** This material is located on the 5<sup>th</sup> floor under carpeting next to the copy and break rooms. One sample was collected for asbestos content; the black mastic was found to contain 4% Chrysotile asbestos.

- **Green with green and white streaks 12- x 12-inch floor tile and black mastic (HM103).** This material is located in the copy and break room on the fifth floor. One sample was collected for asbestos content; the black mastic was found to contain 3% Chrysotile asbestos.

- **Beige with reddish-brown streaks 12- x 12-inch floor tile and black mastic (HM105).** This material is located under carpeting on 4<sup>th</sup> and 5<sup>th</sup> floors as well as visible flooring on the 4<sup>th</sup> floor. Two samples were collected for asbestos content; floor tile was found to contain <1% asbestos, but the black mastic was found to contain 3%-5% Chrysotile asbestos.

Photo 26. ACM black residual mastic under three types of 12-inch vinyl floor tiles- Alder Tower

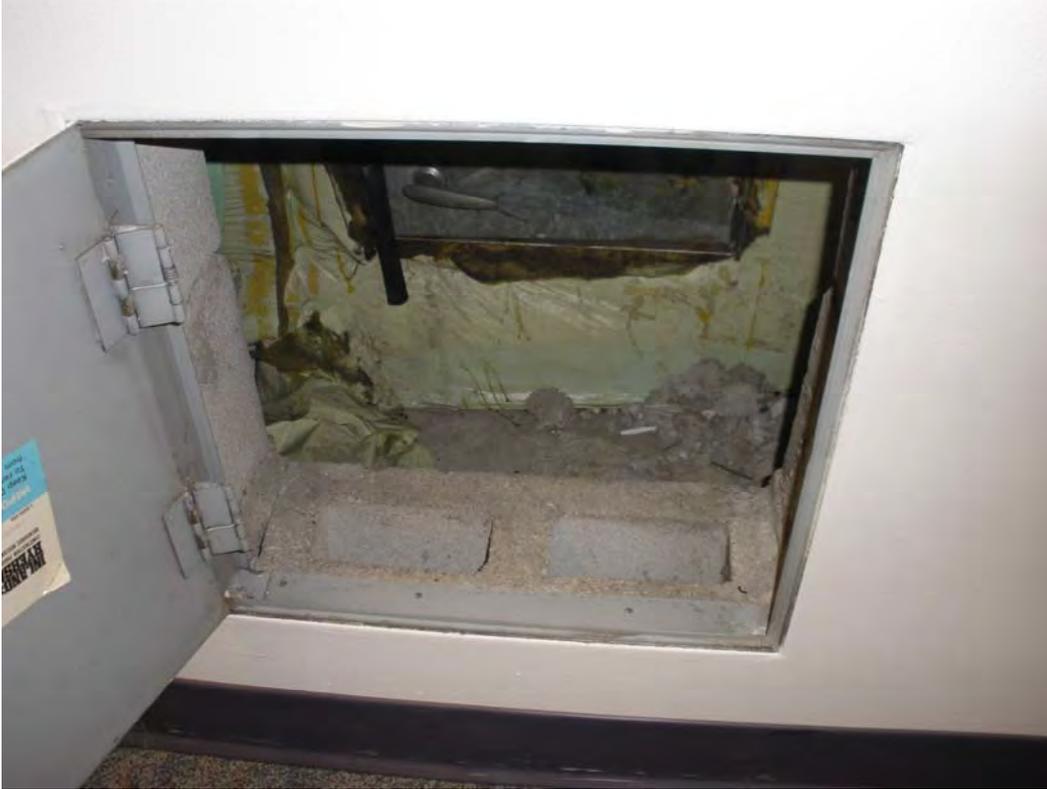
- Insulating cement on exposed fiberglass ends (HM106). This material is located on mechanical system pipe fittings and some hangars throughout the building and was previously sampled and determined asbestos-containing. Additionally, roof drain piping has a similar material and was not previously sampled; roof drain piping is located on the fifth floor and first floor. Three samples were collected for asbestos content; this material was found to contain 3% Chrysotile asbestos.

Photo 27. ACM insulating cement on exposed fiberglass pipe insulation ends, roof drain pipe on 5<sup>th</sup> floor Alder Tower-interior wall between restrooms

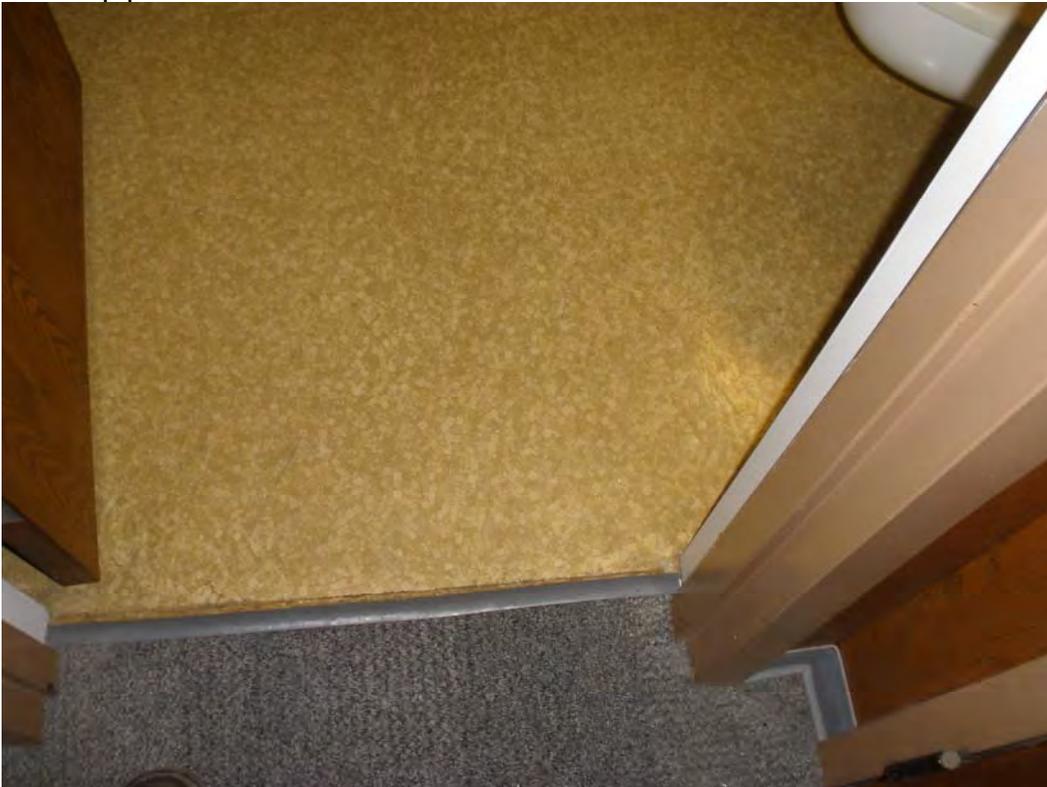
- **Yellow pebble pattern sheet vinyl flooring (HM130)**. This material is located in Court 2-3 restroom and Court 4 restroom on the main floor. Three samples were collected for asbestos content; this material was found to contain 45-55% Chrysotile asbestos.

Photo 28. ACM yellow pebble pattern SVF-Alder Tower main floor Court 2-3 restrooms

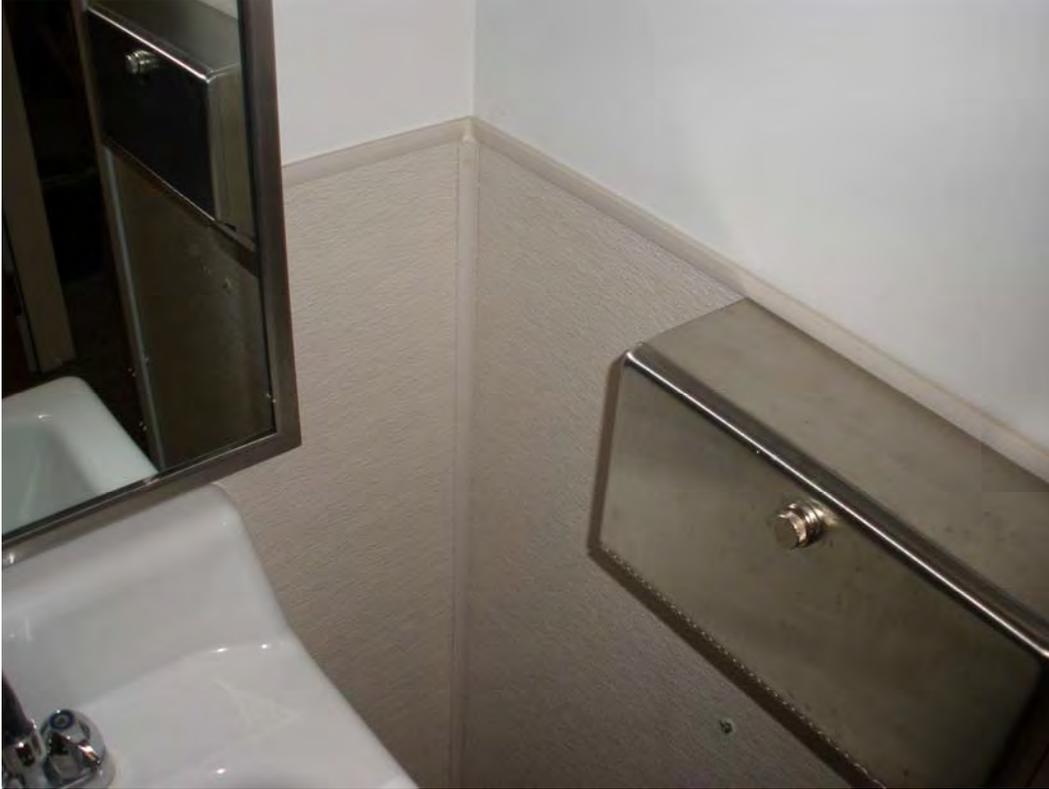
- **Wall paneling mastic (HM132)**. This material is located in Court 3 on the main floor. Three samples were collected for asbestos content; this material was found to contain 3-5% Chrysotile asbestos.

Photo 29. ACM wall panel mastic-Alder Tower main floor Court 3 restroom

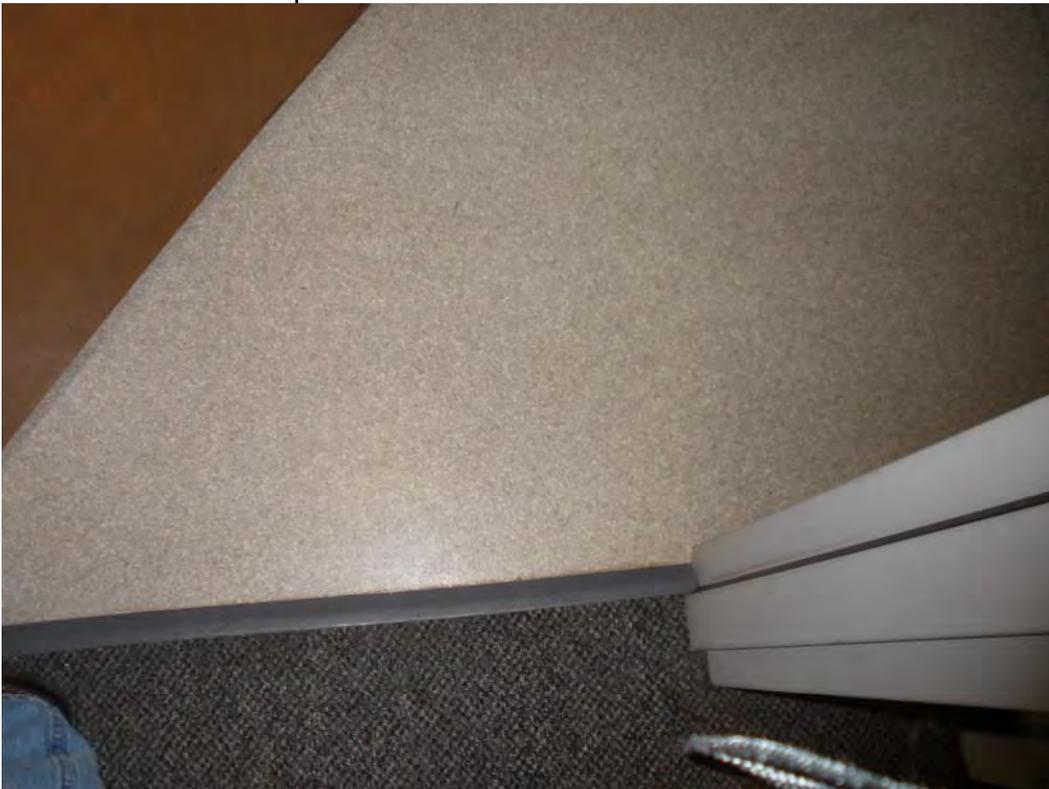
- **Green sheet vinyl flooring (HM78)**. This material is located in the Court 1 restroom on the main floor. One sample was collected for asbestos content; the black asphaltic mastic found as a third sample layer was found to contain 3% Chrysotile asbestos.

Photo 30. ACM green SVF-Alder Tower main floor Court 1 restroom
