Signature Report

Motion 16199

1 A MOTION approving the 2022 King County Repetitive
 2 Loss Area Analysis Report for transmittal to the Federal
 3 Emergency Management Agency.

2022 REPETITIVE LOSS AREA ANALYSIS – EXTERNAL VERSION

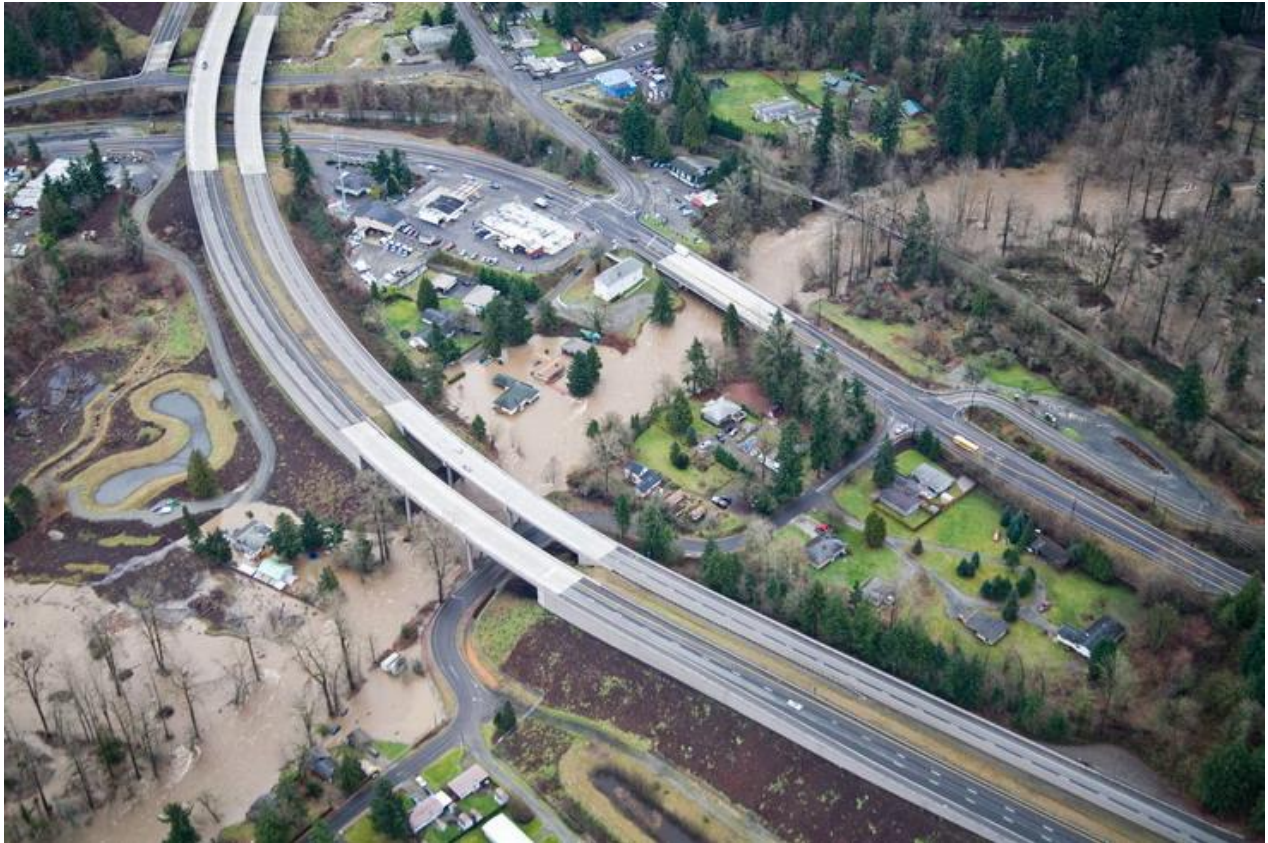
Cedar River at SE 218th Street. January 7, 2009.

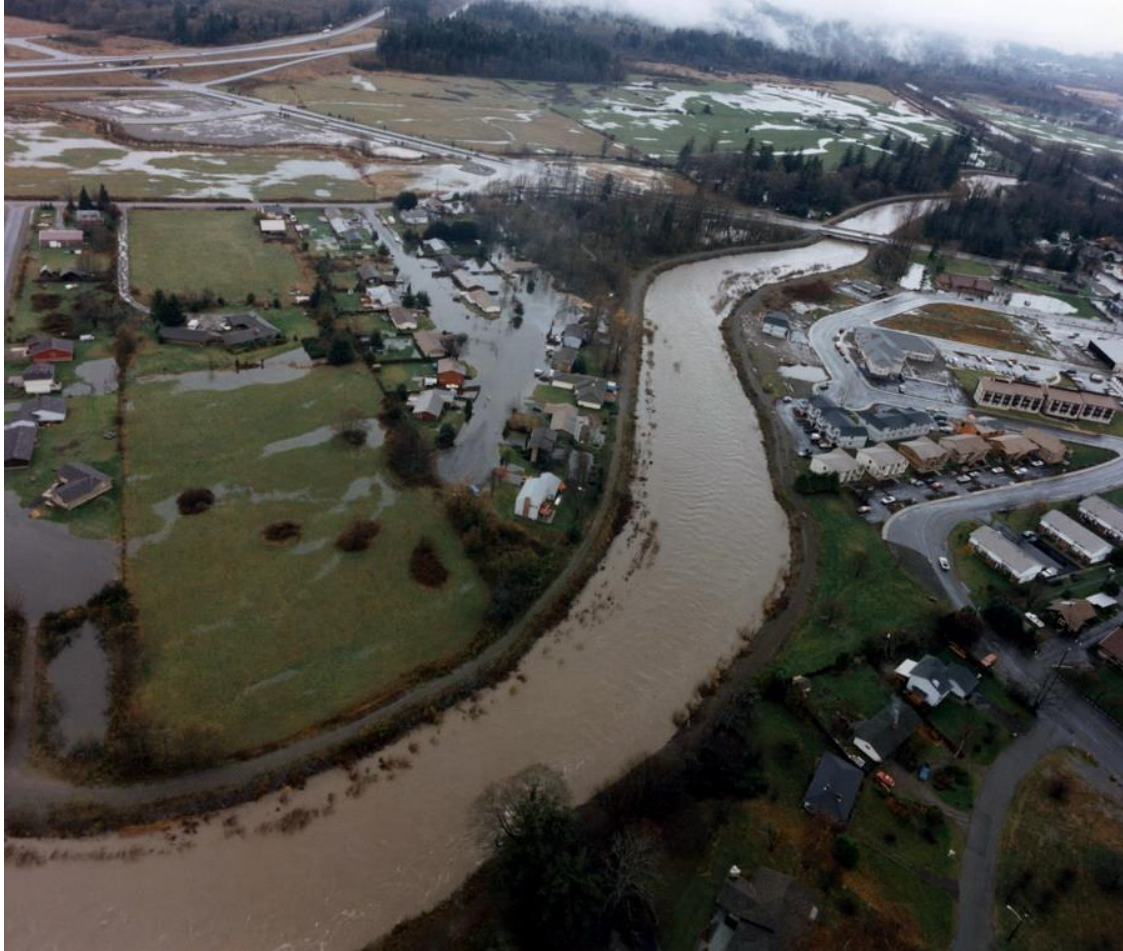
Snoqualmie River at 413th Avenue SE (Shamrock Park). November 23, 1986.
