King County

REPETITIVE LOSS AREA ANALYSIS

July 11, 2022

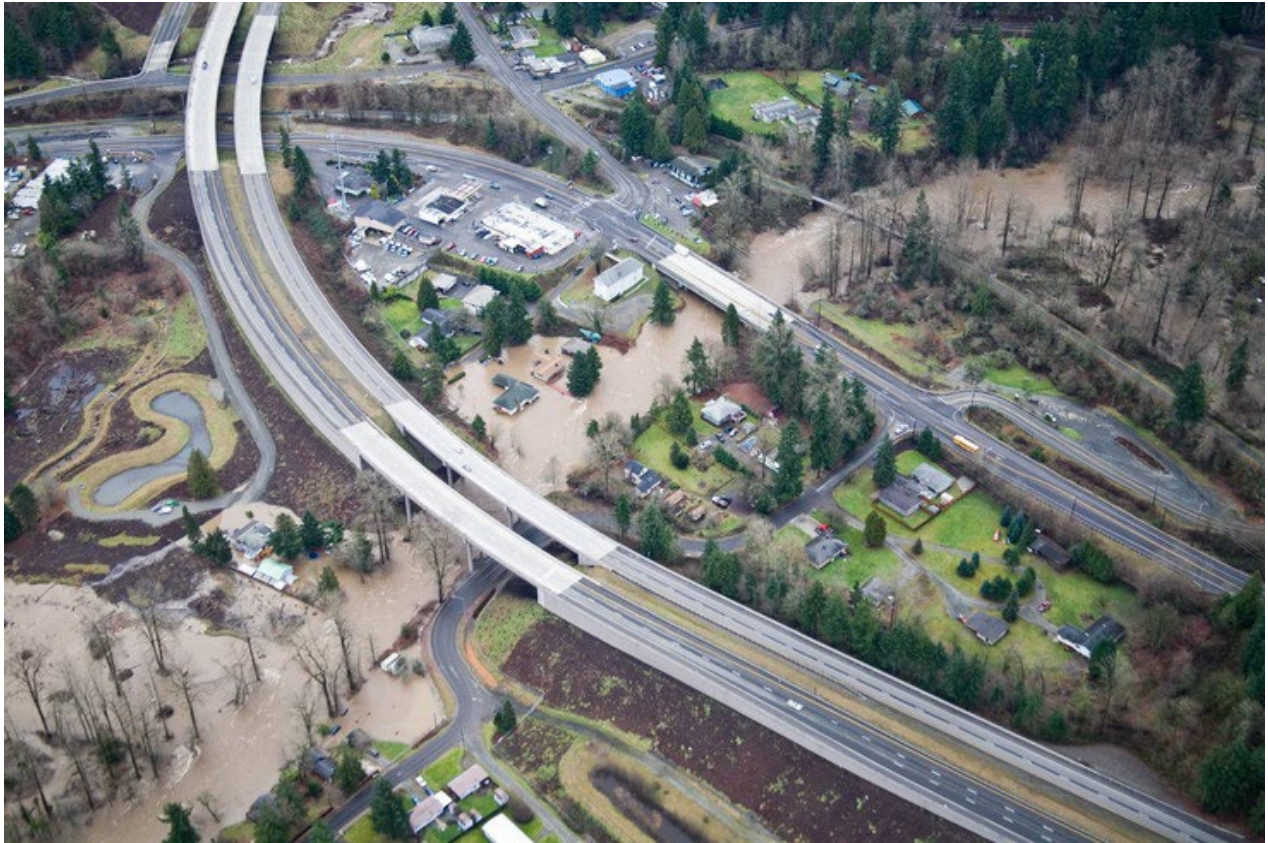
Cedar River at SE 218th Street. January 7, 2009.

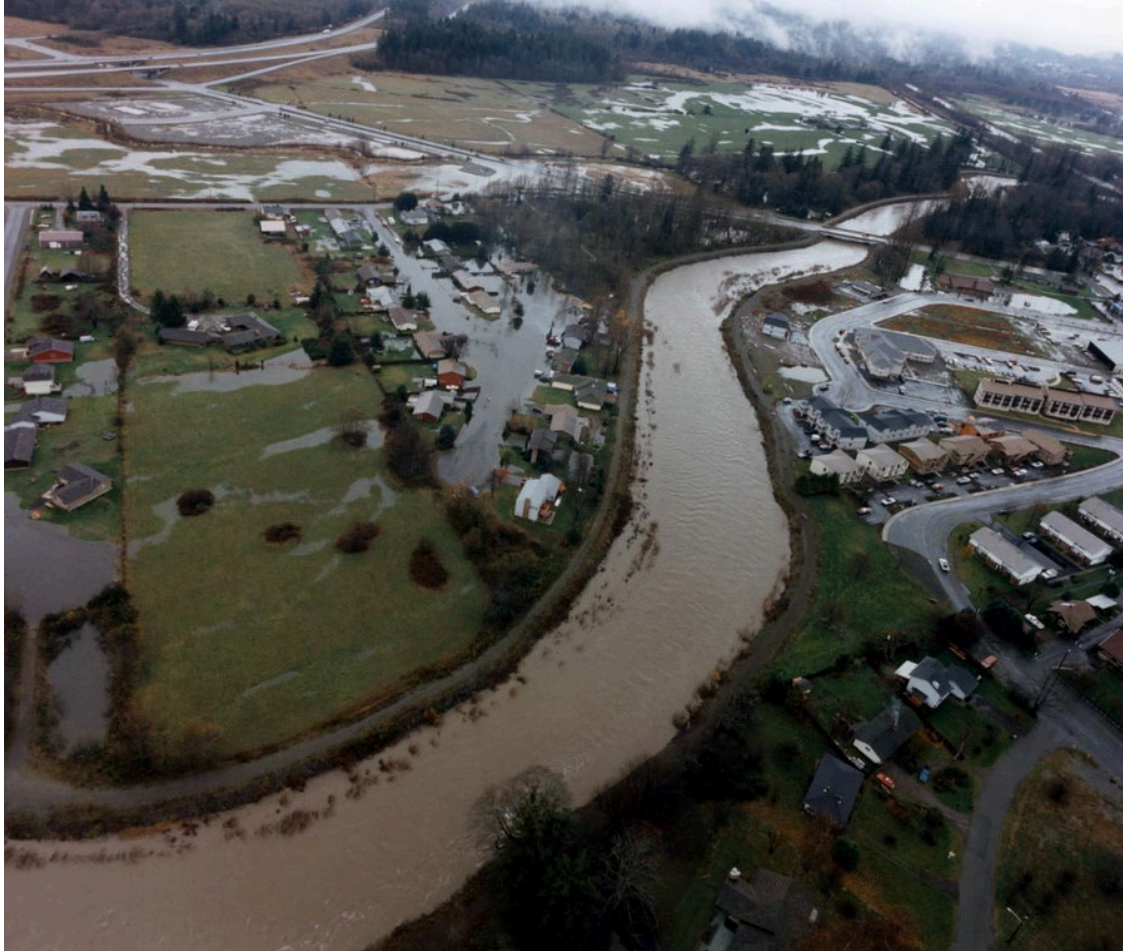
Snoqualmie River at 413th Avenue SE (Shamrock Park). November 23, 1986.
