Signature Report

Motion 16200

Fairwood Golf and Country Club Flooding Report

August 1, 2022

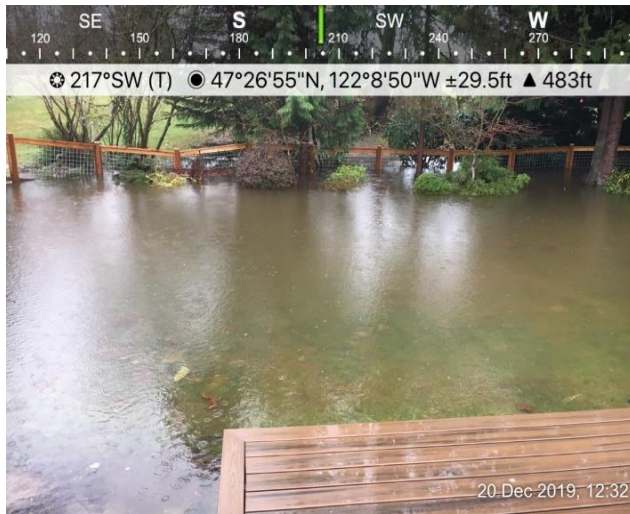
Flooding from the December 20, 2019, storm event is shown in Photos 1 and 2.

Photo 2: Looking southwest at the backyard of 14609 SE 173rd St.

By working with FGCC staff after the initial flooding report in 2010, WLRD determined that roots had grown into the concrete pipe downstream of CB A. Root intrusion into pipes is common and results in reduced capacity for the pipe system.⁷ Not only do the roots reduce the capacity of a pipe, but they also act like a strainer, catching debris that would otherwise flow through the pipe. Over time, root intrusion can lead to complete blockage of a pipe.

In response to previous flooding events, the FGCC inspected the pipe system downstream of CB A and hired a contractor to cut the roots that had entered a pipe. Cutting roots from a pipe improves conveyance capacity but does not remove all roots from the pipe; the roots will grow back in almost all cases. WLRD recommended the FGCC develop a plan for dealing with the anticipated regrowth of the

roots in the pipe. Components of such a plan could include inspecting the pipe on a regular basis, cleaning the pipe when needed, and removing the trees with roots that were suspected of growing into the pipe.

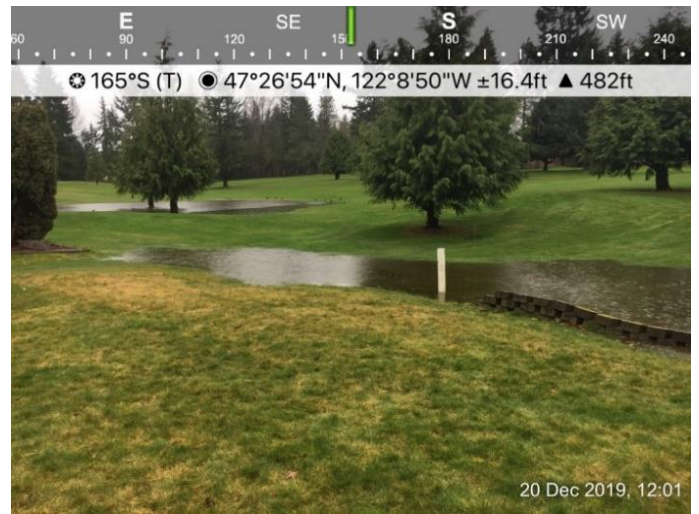
Photo 1: Looking southeast from the backyard of 14609 SE 173rd St. at the flooding on the fairway and rough of the 18th hole of the FGCC.
