Kenmore Interceptor Report

March 2020

King County

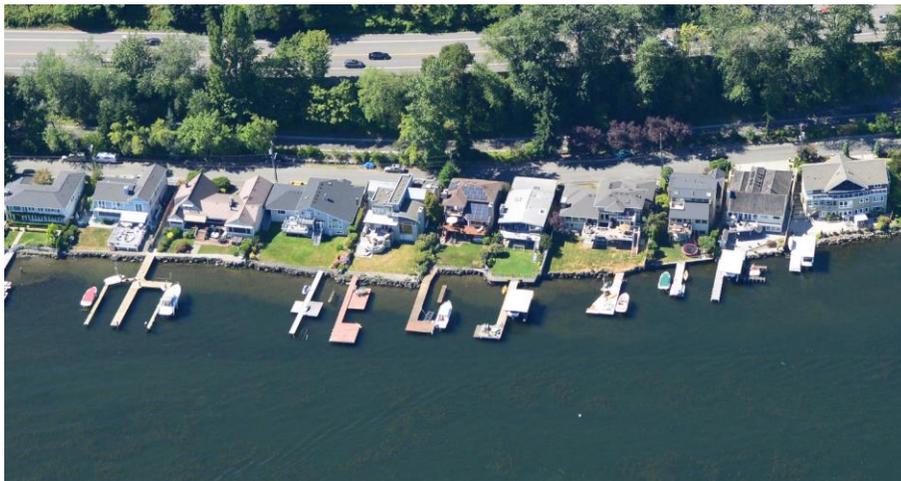
Figure 3
Study Area Typical Shoreline Condition

Today, shoreline conditions along Sheridan Beach and Beach Drive NE generally consist of managed grass lawns, few to no trees or other overhanging vegetation, docks (which vary in length from 50 feet to 375 feet), and small overwater structures such as boat houses. Nearly every property adjacent to the shore has a private dock. In total, 56 docks span the 4,700 feet of shoreline in the study area, which corresponds to a dock density of one structure per 80 feet. The shoreline is also heavily armored by revetments and bulkhead walls, occasionally punctuated by managed sandy pocket beaches. Figure 3 shows the typical shoreline conditions along Beach Drive NE.

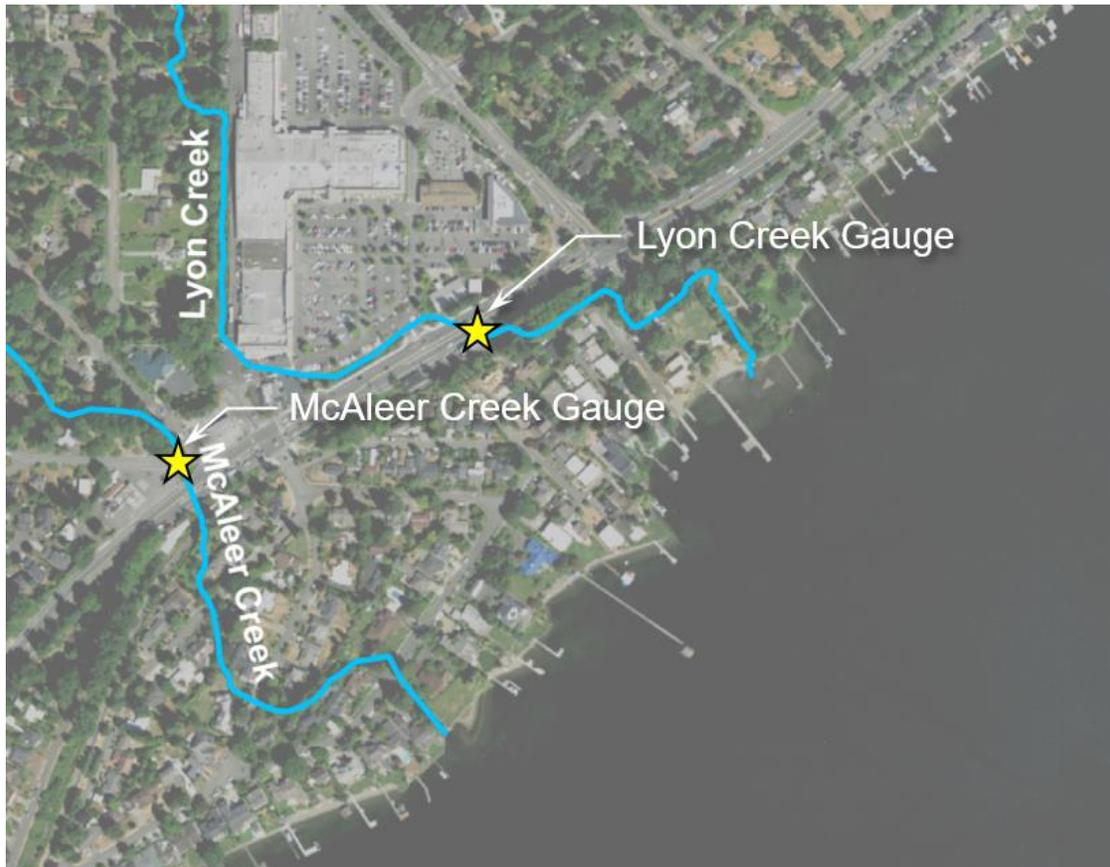
Figure 22
Stream Gauge Locations

Streamflow and water quality parameters are monitored by the USGS and King County at stream gauges on Lyon and McAleer Creeks (Figure 22). A record of 15-minute streamflow is available for both creeks and is shown for each creek's respective length of record in Figure 23. Figure 24 summarizes the peak annual discharge in each stream.

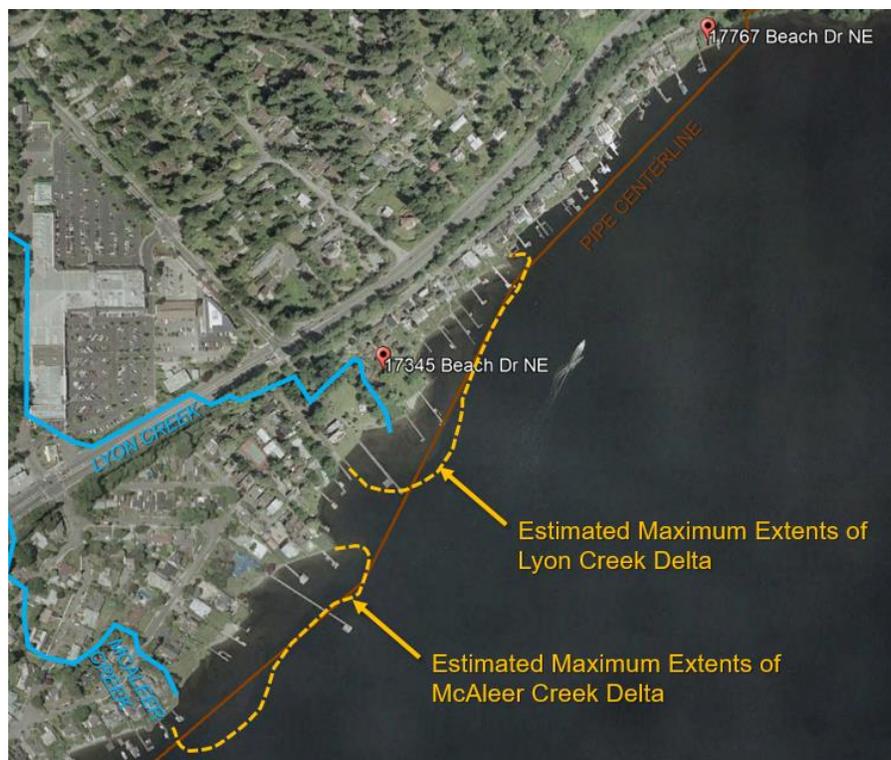
Figure 26
Extents of Lyon and McAleer Creek Deltas
Estimated from Aerial Images

Culvert replacement projects described in Section 3.2.2.3 have likely further increased the amount of coarse material reaching the creek deltas in the years since the replacements, which occurred in 2014–2019.
