EXECUTIVE DETERMINATION OF EMERGENCY, WAIVER FROM COMPETITIVE
PROCUREMENT REQUIREMENTS FOR THE BALLARD SIPHON REPLACEMENT IN
THE WASHINGTON SHIP CANAL

KING COUNTY
REPORT ON A
SONAR PROFILING SURVEY
BALLARD SIPHON
SEATTLE, WA

Subject: Ballard Siphon

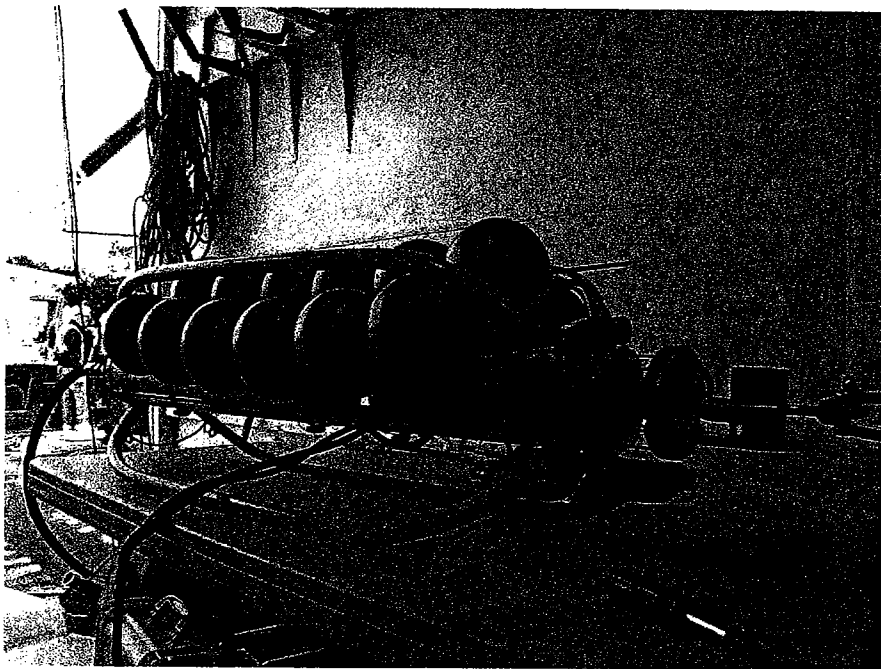
Photo 2: Sonar System Probe

Shown with floatation and skids, in the operations trailer

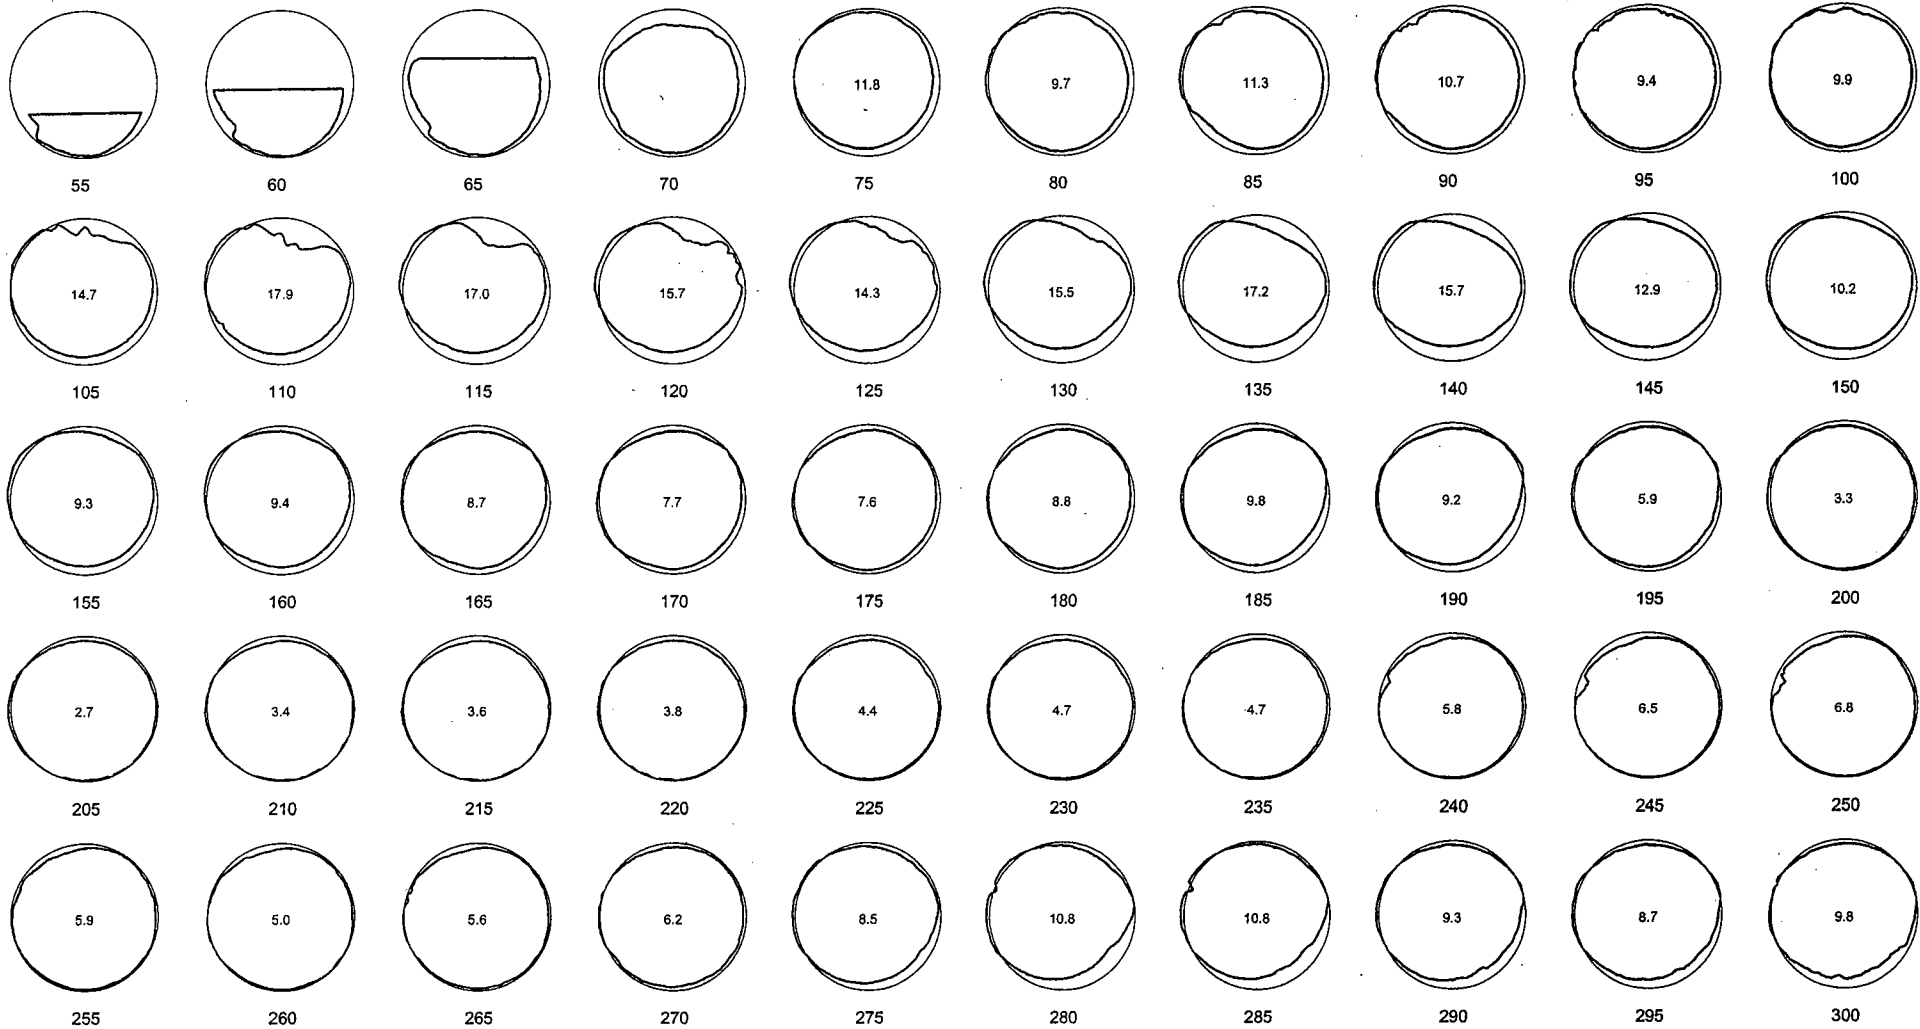
KING COUNTY BALLARD SIPHON		
SEWER INSPECTION SURVEY		
BALLARD WEST WOOD STAVE PIPE CROSS SECTIONS 55 - 300		
FRONTIER GEOSCIENCES INC.		
DATE: NOV 2005	SCALE 1 IN = 2.5 FT	DWG: BW-SEC-1

The north section of the siphons was dry to a chainage of 50 feet. The sonar data begins with a partially filled pipe from 55 feet to 70 feet. A number of features were noted in the traverse of the pipes. The most prominent of these is seen as in the west pipe data as cross-section change extending from 100 feet to 150 feet. This appears to be a crown incursion, possibly related to failure of the wood stave structure of the pipe crown. The onset of the fault is fairly abrupt at the 100 foot mark with a tapering of the effect to a minor cross-section change at a distance of 150 feet. A peak value of 17.9 percent obstruction of the pipe over the nominal 36 inch equivalent is measured. An example sonogram at 103.9 feet is contrasted below with a normal pipe section at a cable payout distance of 152.9 feet. In these images the probe position appears as a diffraction star just above the pipe invert.

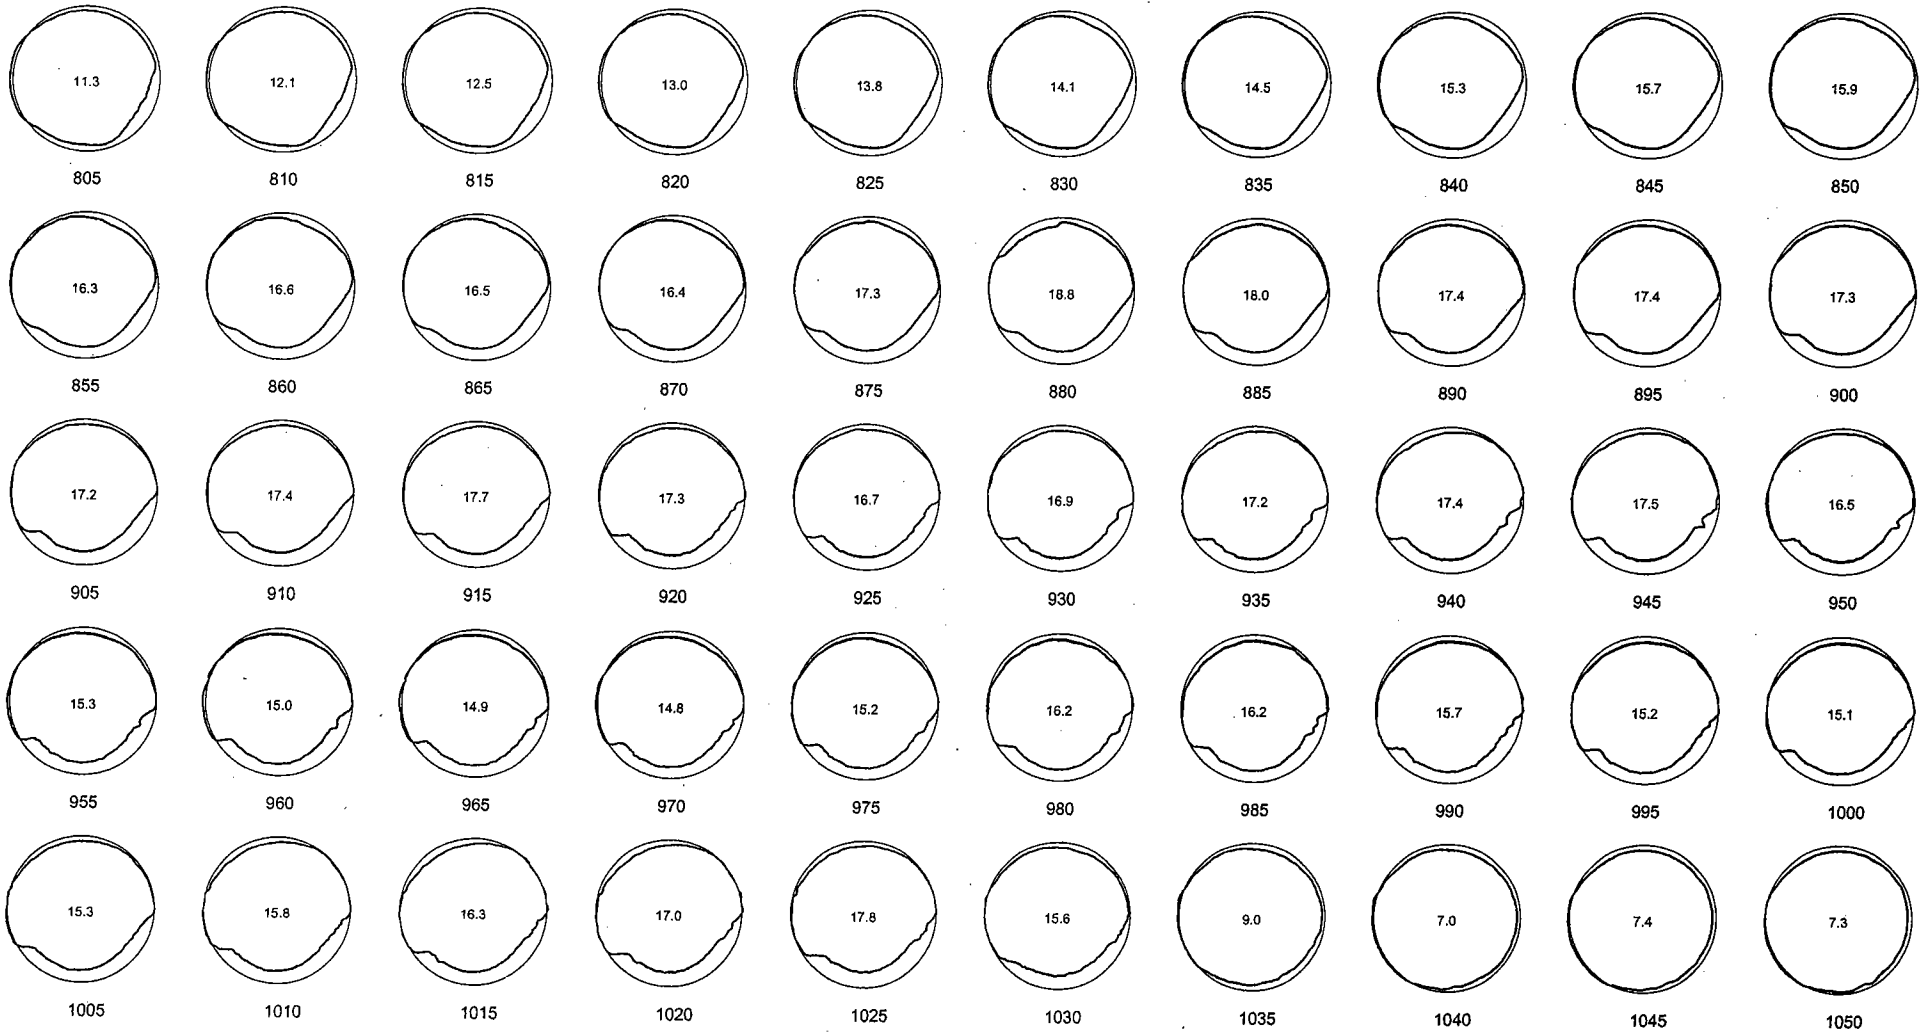
KING COUNTY		
BALLARD SIPHON		
SEWER INSPECTION SURVEY		
BALLARD WEST WOOD STAVE PIPE CROSS SECTIONS 805 - 1050		
FRONTIER GEOSCIENCES INC.		
DATE: NOV 2005	SCALE 1 IN = 2.5 FT	DWG: BW-SEC-4

The longest section of sediment or debris in the pipe is observed in the 750 to 1035 foot range, along the central area of the horizontal section. In this section of the siphon the percent obstruction is typically in the 15 percent range, with a peak values in the 18 percent range. A typical sonagram from this section is shown below.

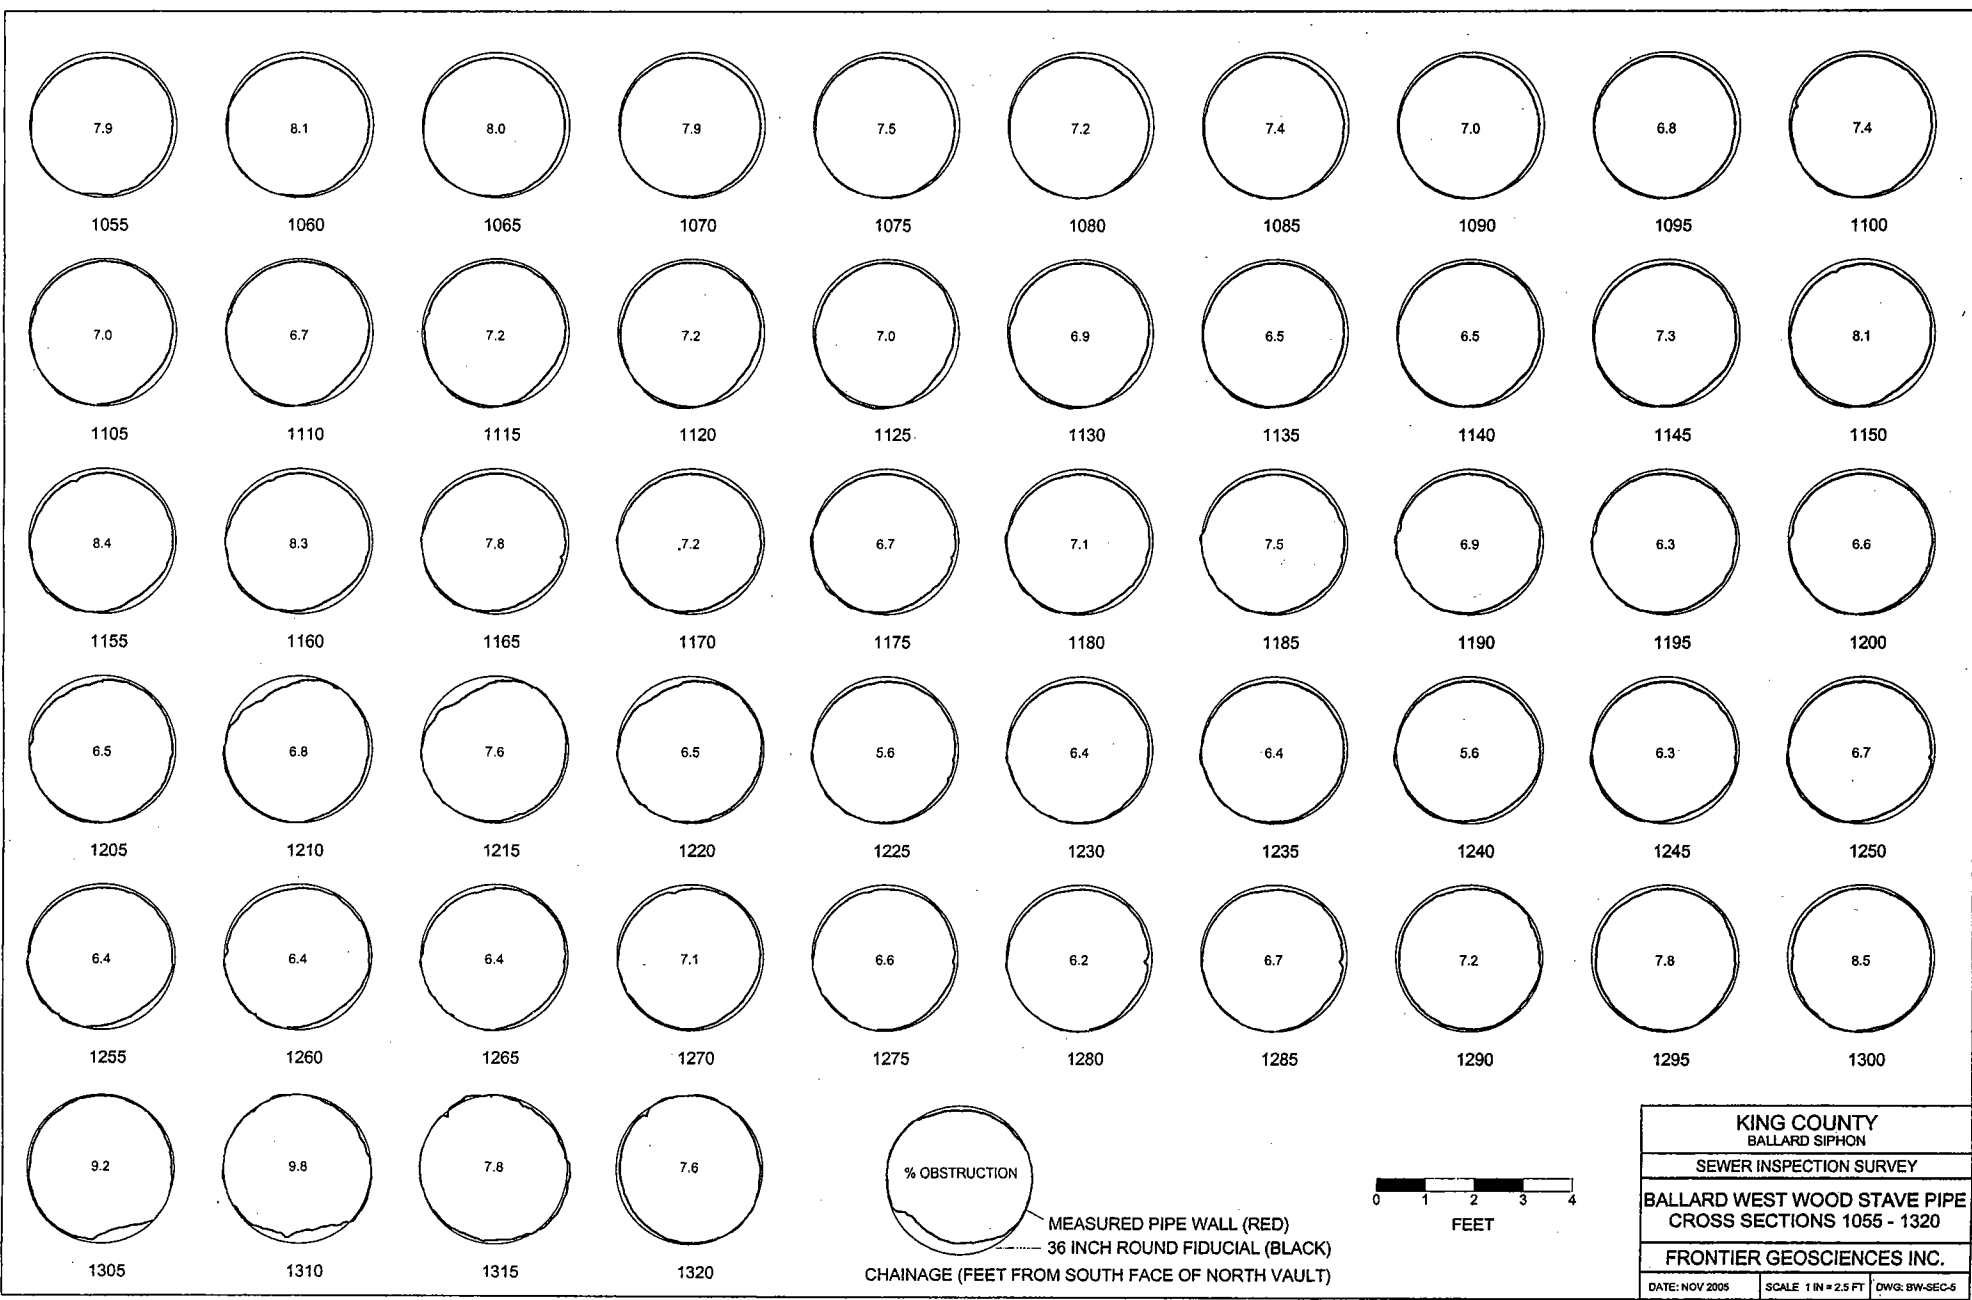
KING COUNTY		
BALLARD SIPHON		
SEWER INSPECTION SURVEY		
BALLARD WEST WOOD STAVE PIPE CROSS SECTIONS 1055 - 1320		
FRONTIER GEOSCIENCES INC.		
DATE: NOV 2005	SCALE 1 IN = 2.5 FT	DWG: BW-SEC-5

Overall, based on a comparison with an ideal 36 inch pipe, the total obstructed area observed in the west siphon results in a calculated sediment volume of 834 cubic feet. South of the 1080 foot distance the siphon ascends at a steeper gradient to the south afterbay. Approximately mid-point in this ascending segment the siphon shows a more subtle cross-section change in the 1205 to 1220 foot range. An example of the data from this area is displayed as follows.
