**MEDTOX – HERRERA HAZMAT SURVEY 2010**

## HAZARDOUS BUILDING MATERIALS SURVEY

Alder Wing and Alder Tower, Youth  
Services Center  
1211 East Alder Street  
Seattle, Washington 98122

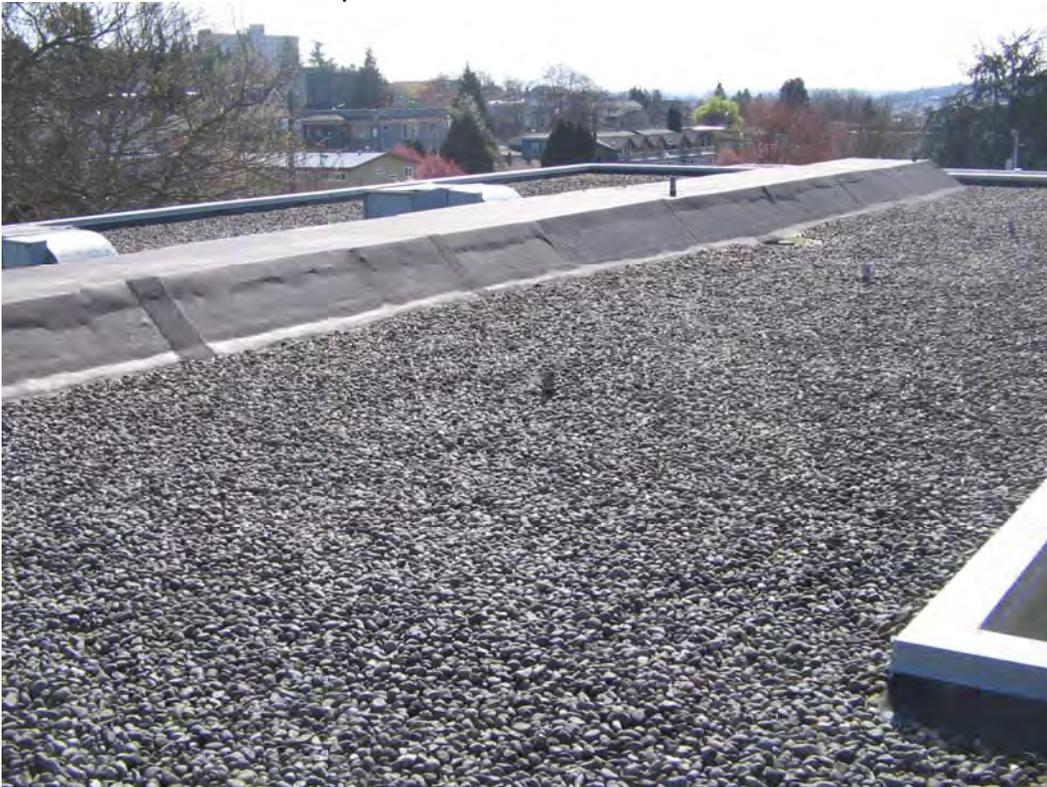
Photo 18. Alder roof looking southeast at raised duct chase

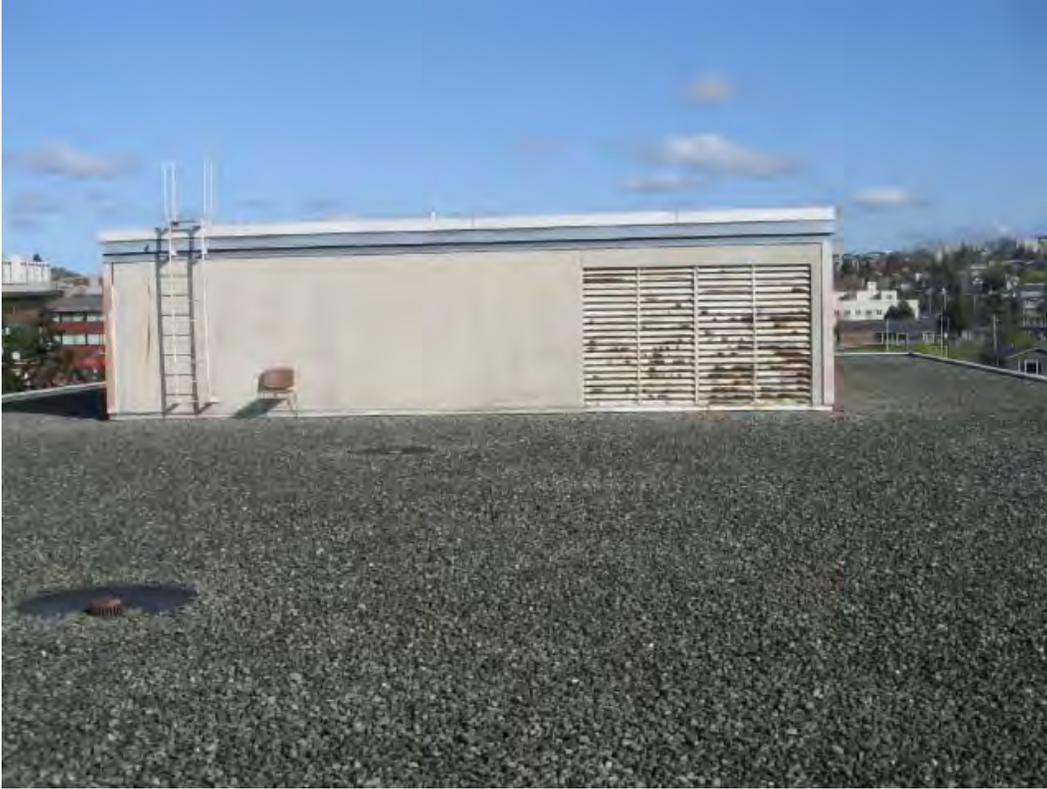
Photo 21. North penthouse/mechanical room on Alder Tower

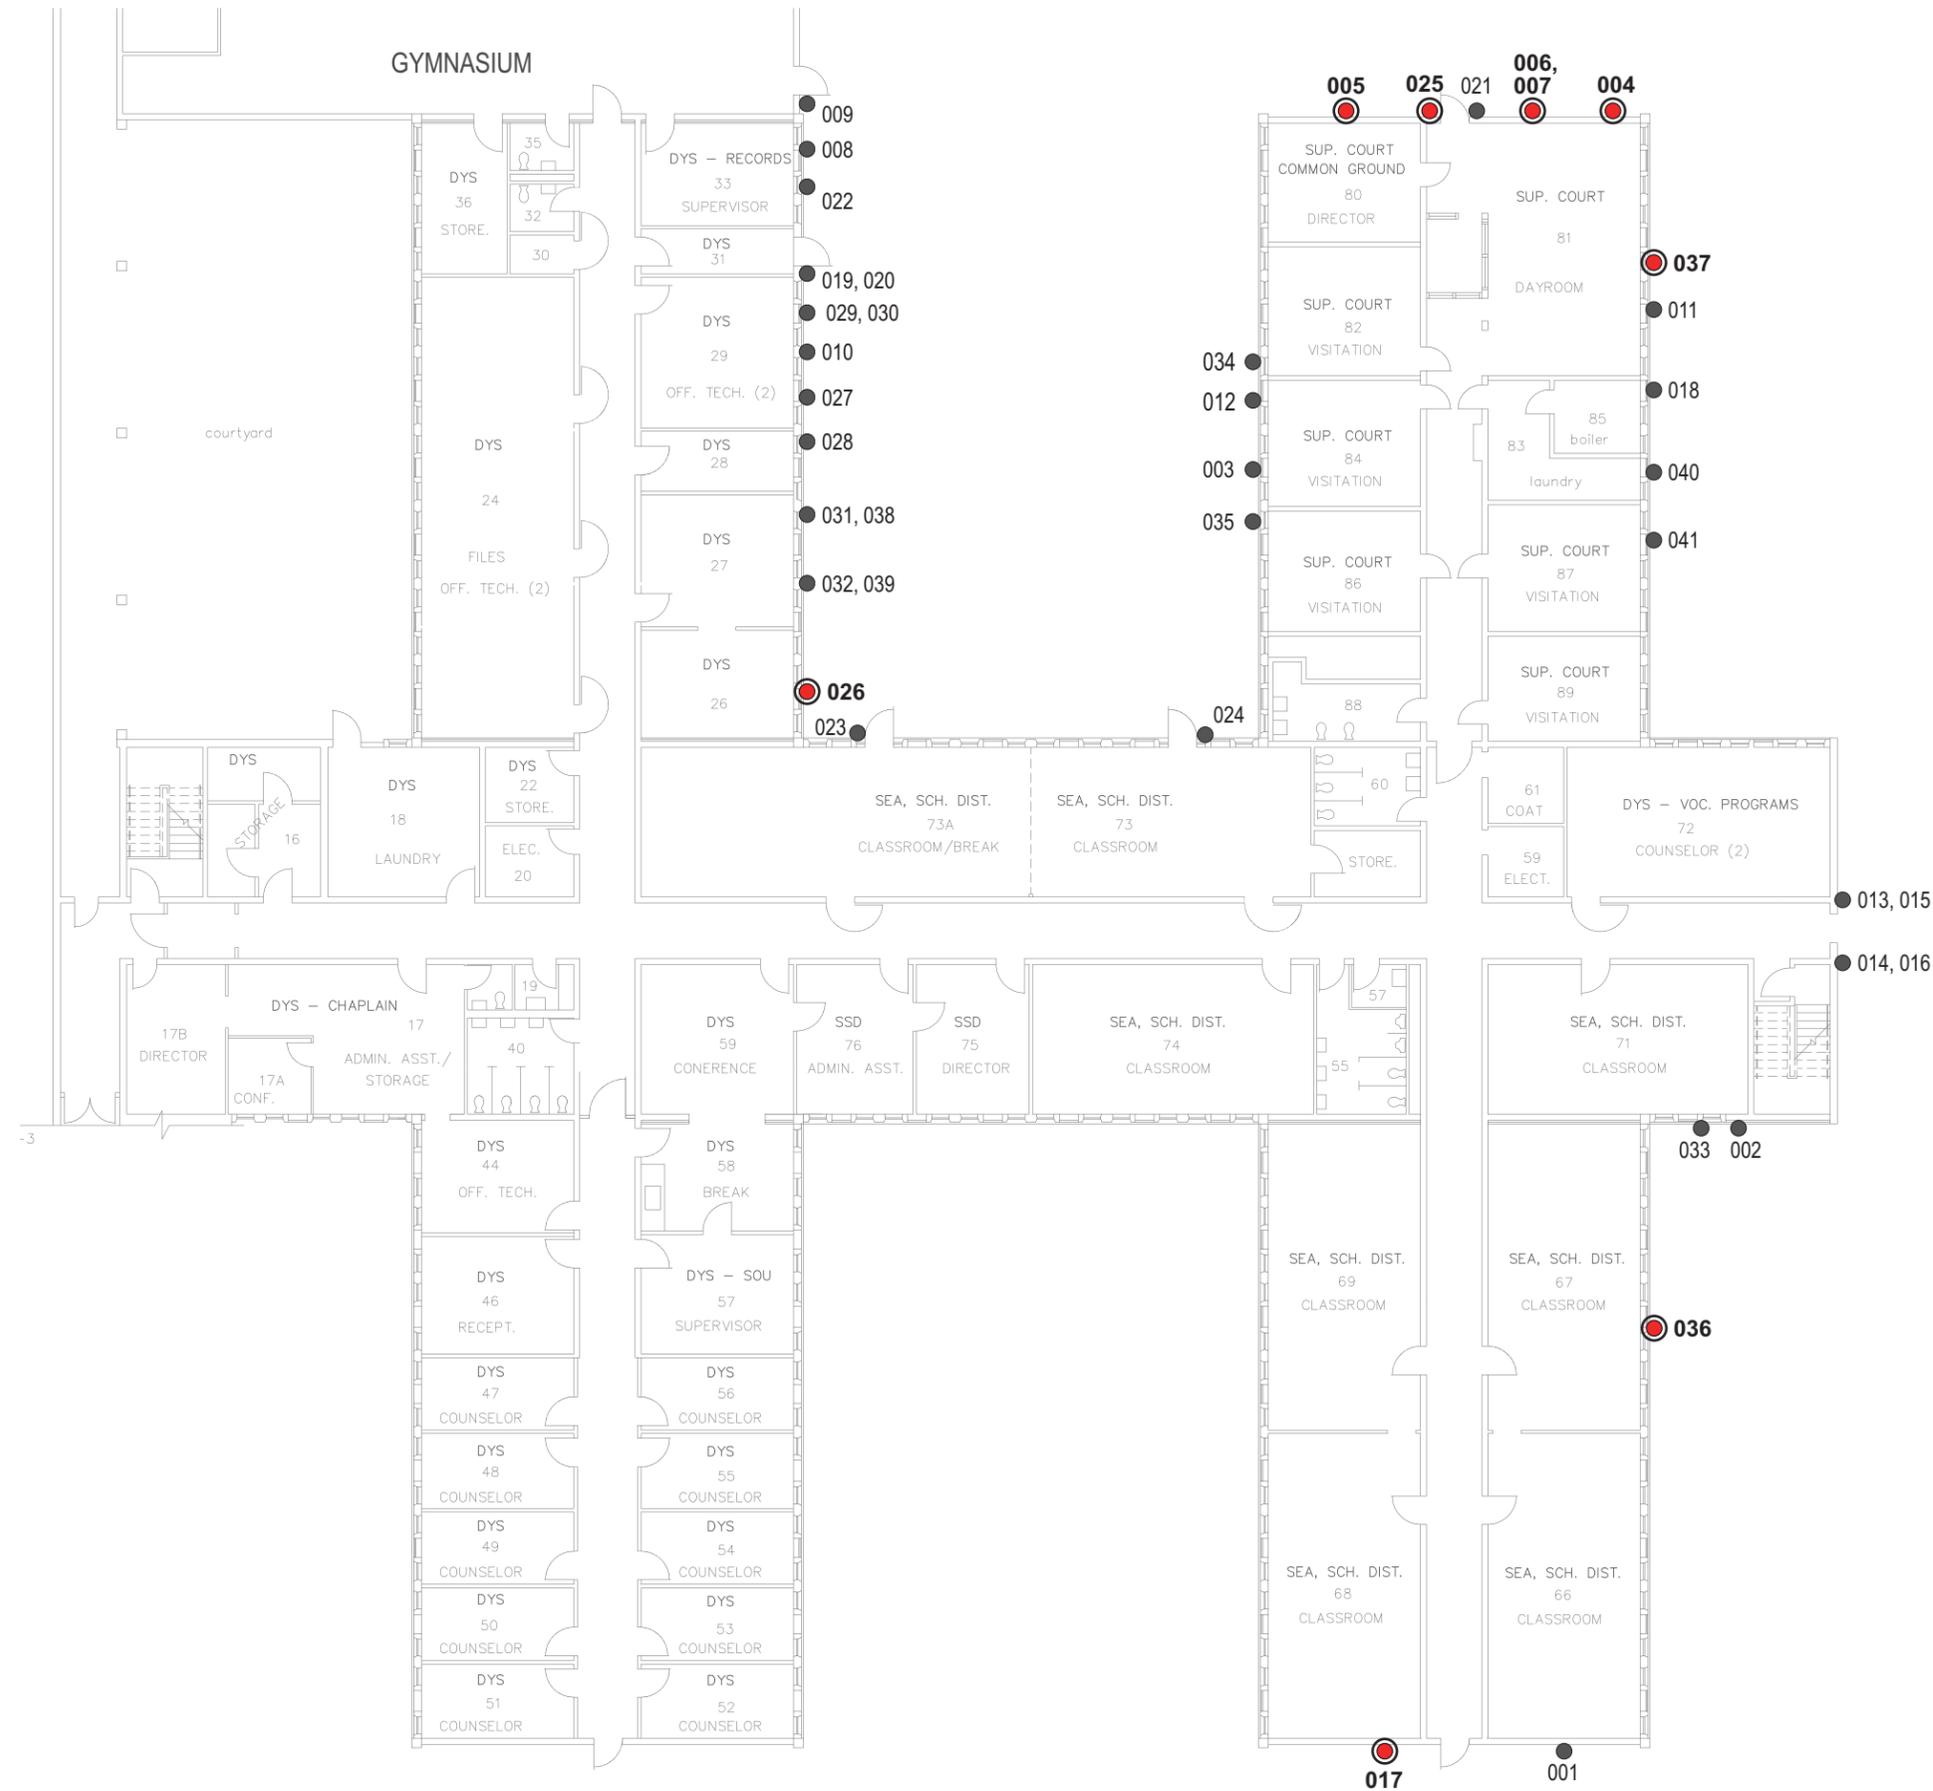
**Figure D-2.**  
**Alder Wing Exterior asbestos**  
**sampling location map, Youth**  
**Services Center, Seattle,**  
**Washington.**

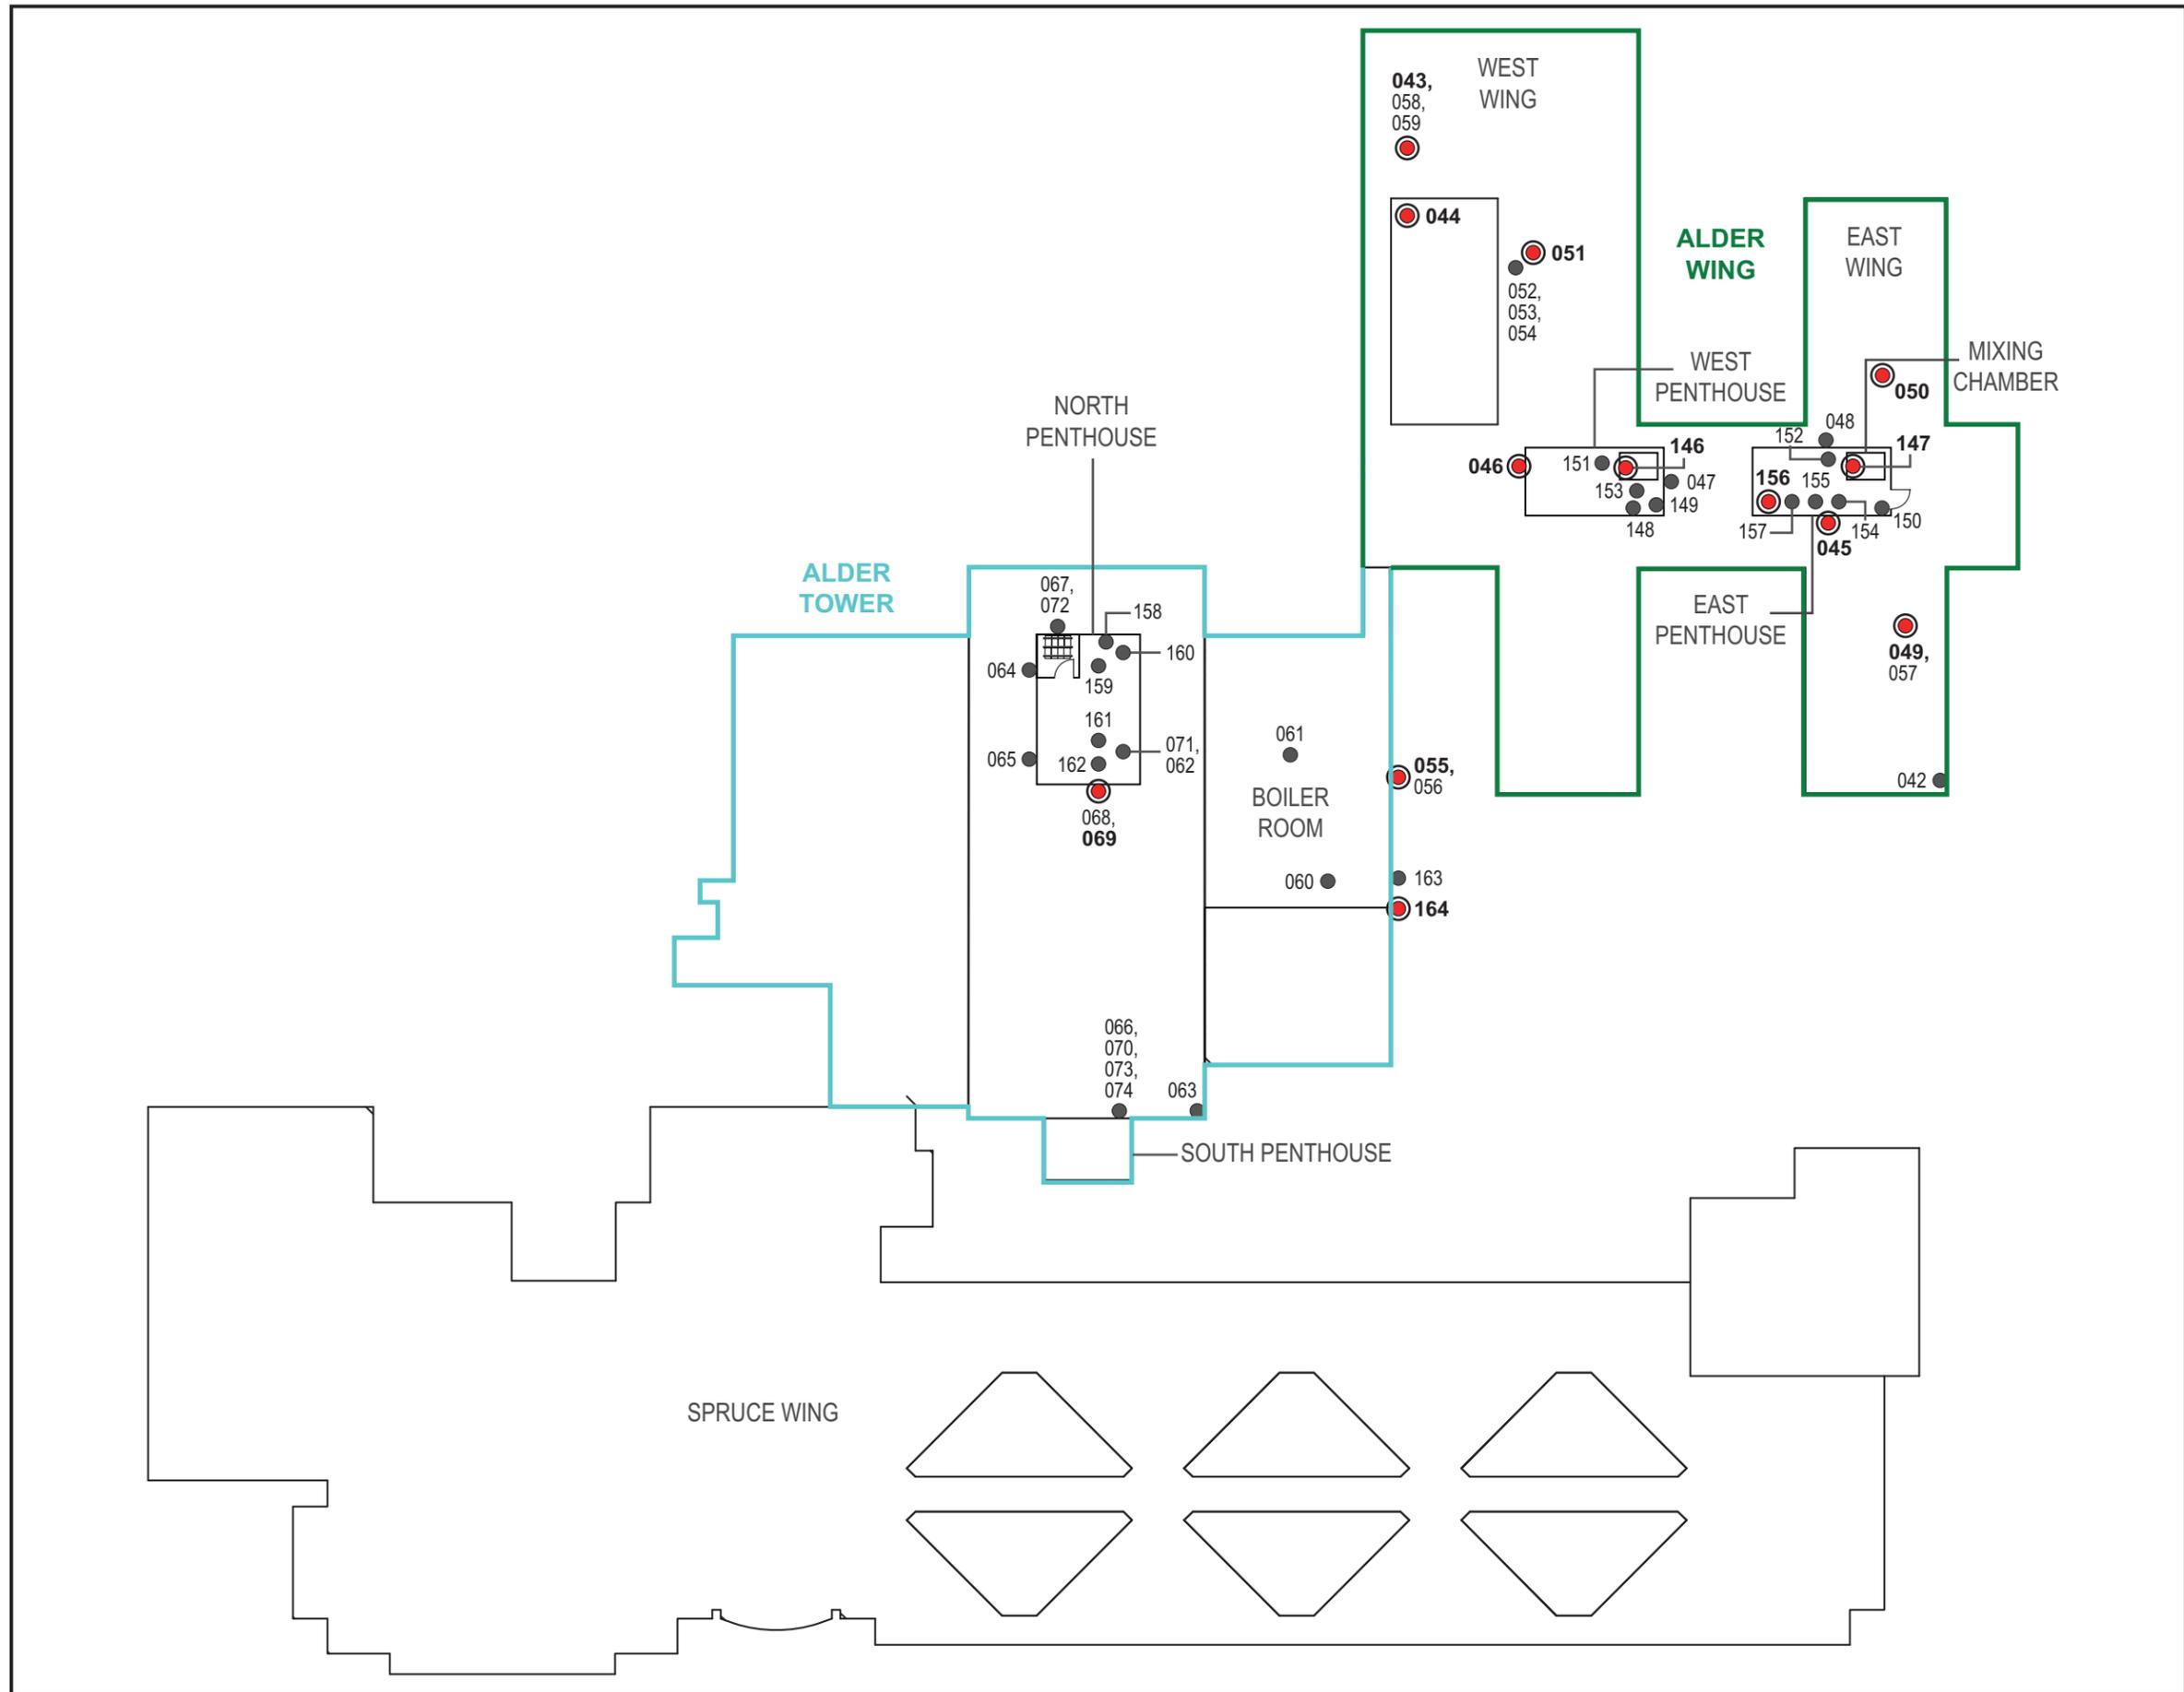
**Figure D-3.**  
**Alder Wing Roof and Alder Tower**  
**Roof asbestos sampling location**  
**map, Youth Services Center, Seattle,**  
**Washington.**

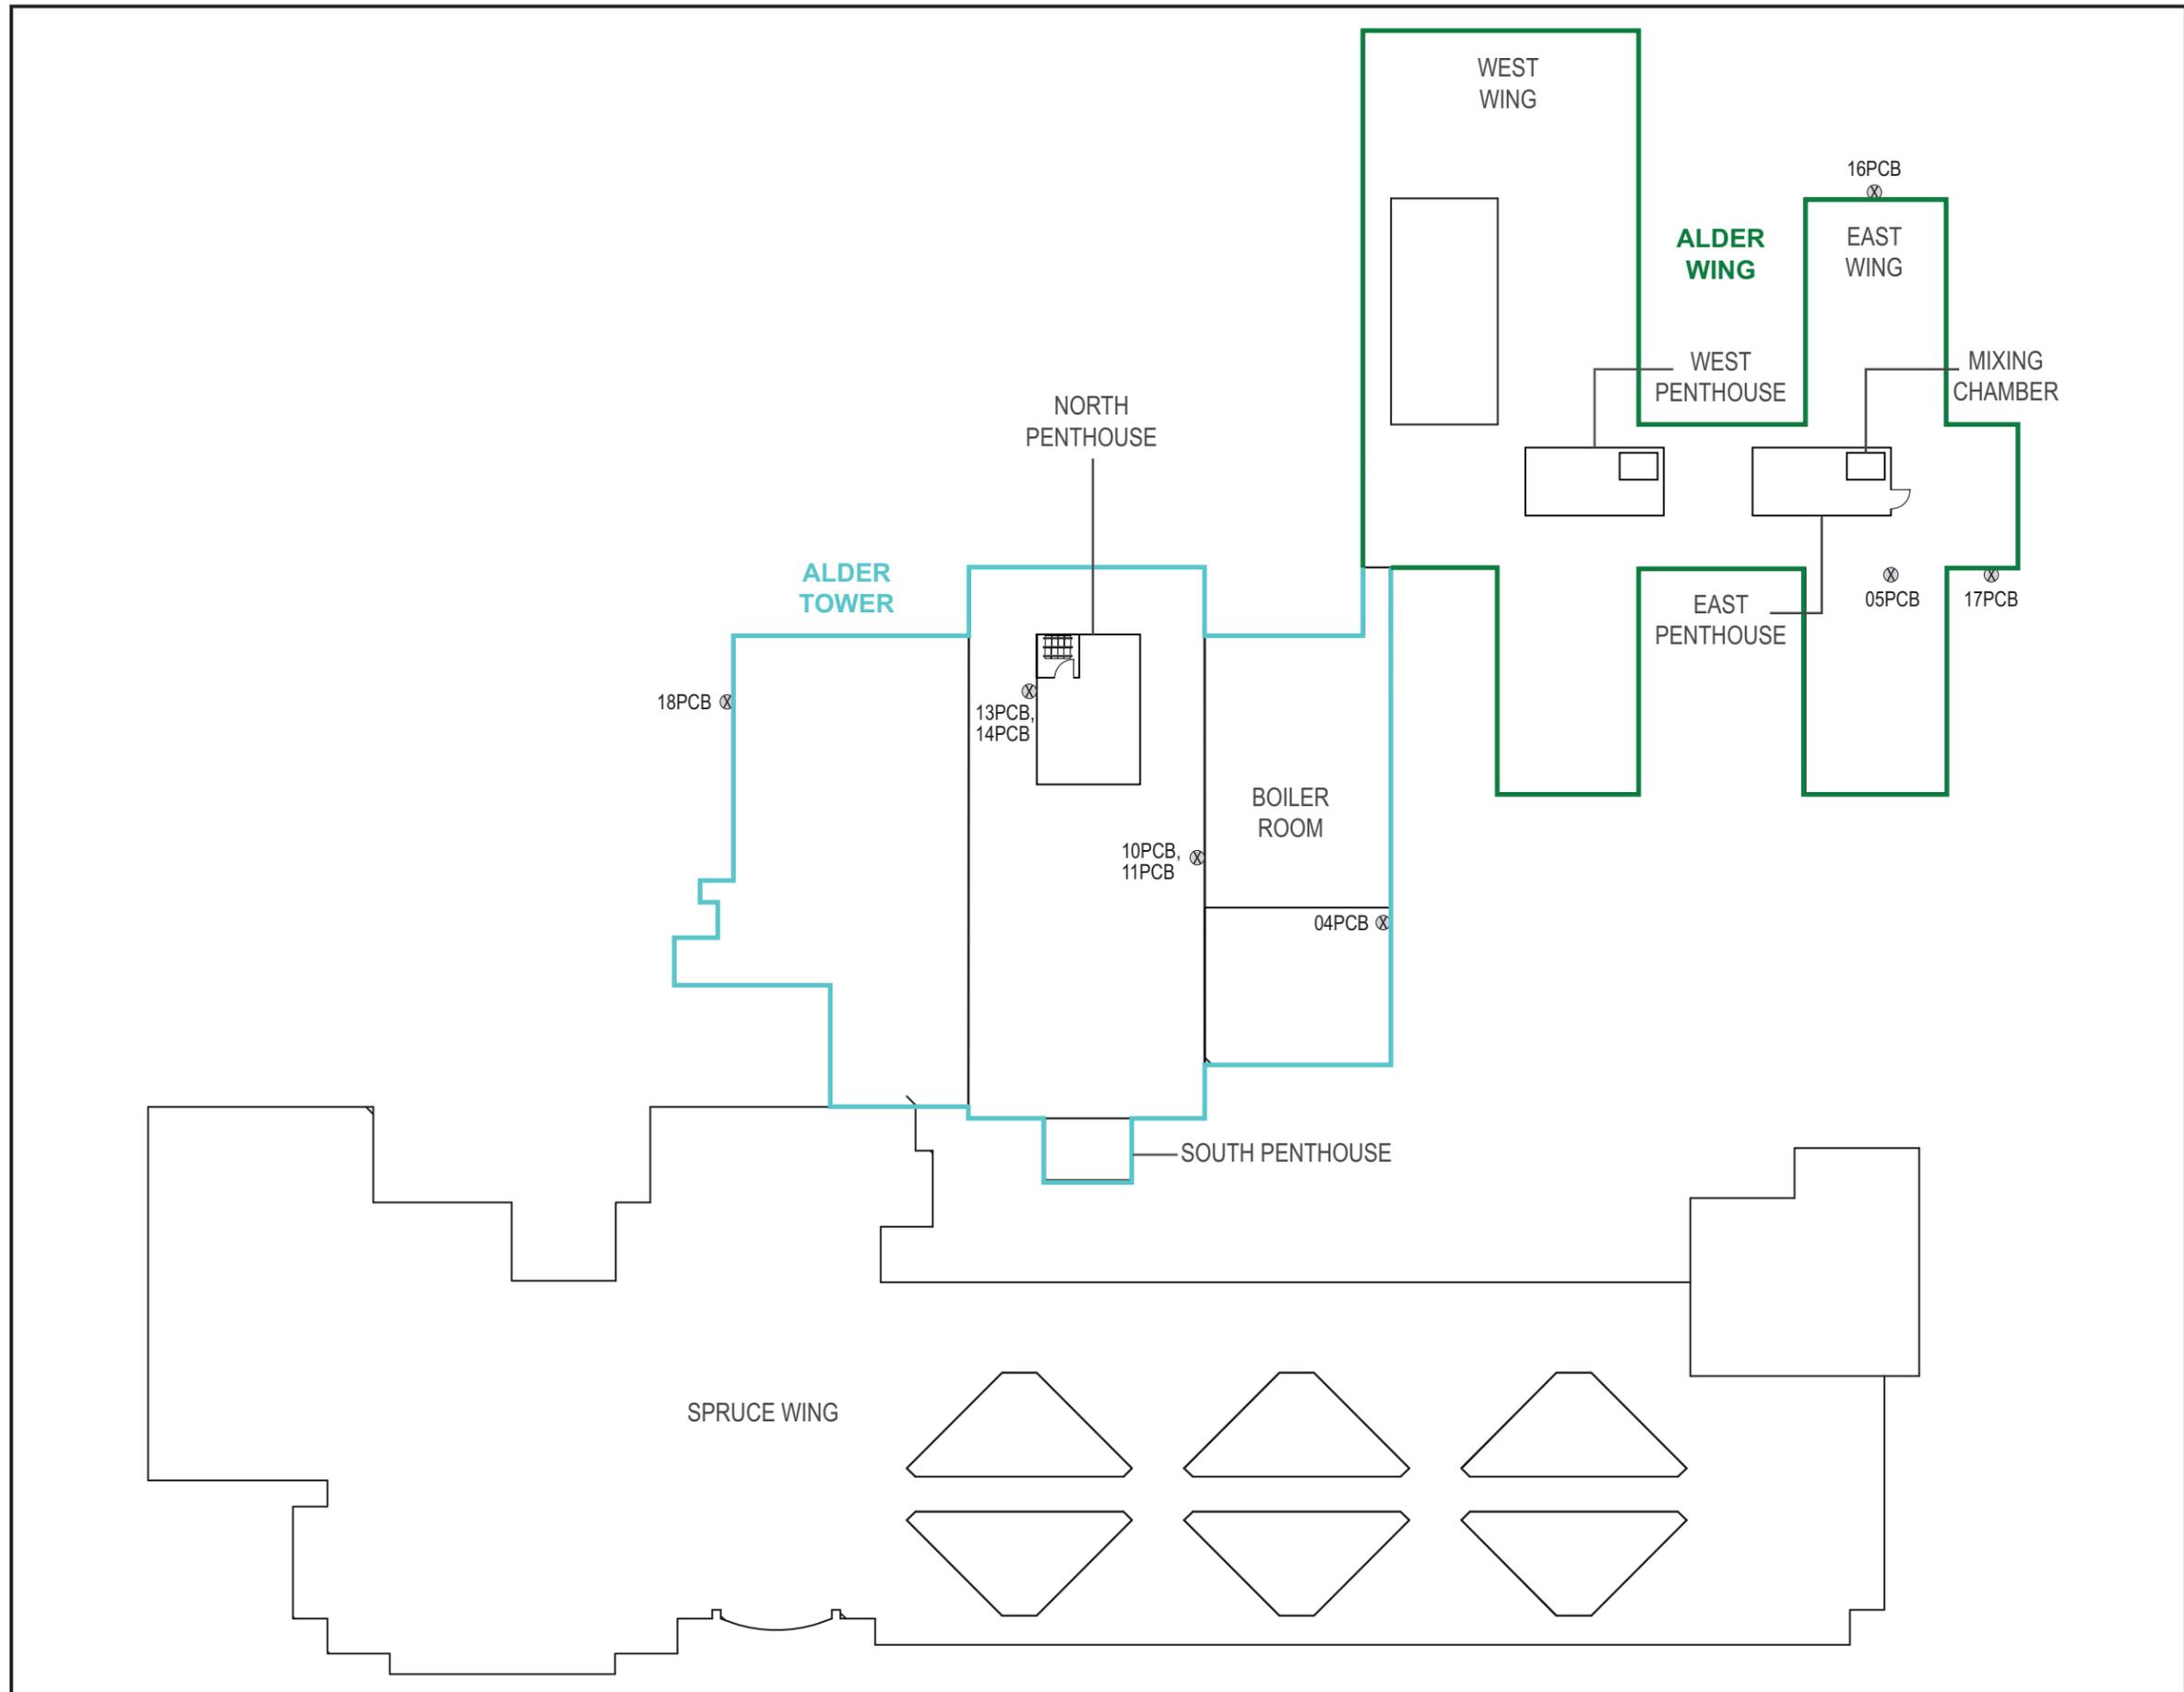
**Figure D-11.**  
**Alder Wing Roof and Alder Tower**  
**Roof polychlorinated biphenyl (PCB)**  
**sampling location map, Youth**  
**Services Center, Seattle,**  
**Washington.**

PCB-containing window caulking on the Alder Tower will require abatement and disposal as an extremely hazardous waste (trigger is 10,000 mg/kg). Med-Tox Northwest also recommends testing concrete surfaces surrounding the caulking material and soils at the base of the building as these are likely contaminated from the PCB caulking although more likely as a state persistent waste. Reporting and consultation with the Department of Ecology may be required, depending on soil sampling results.

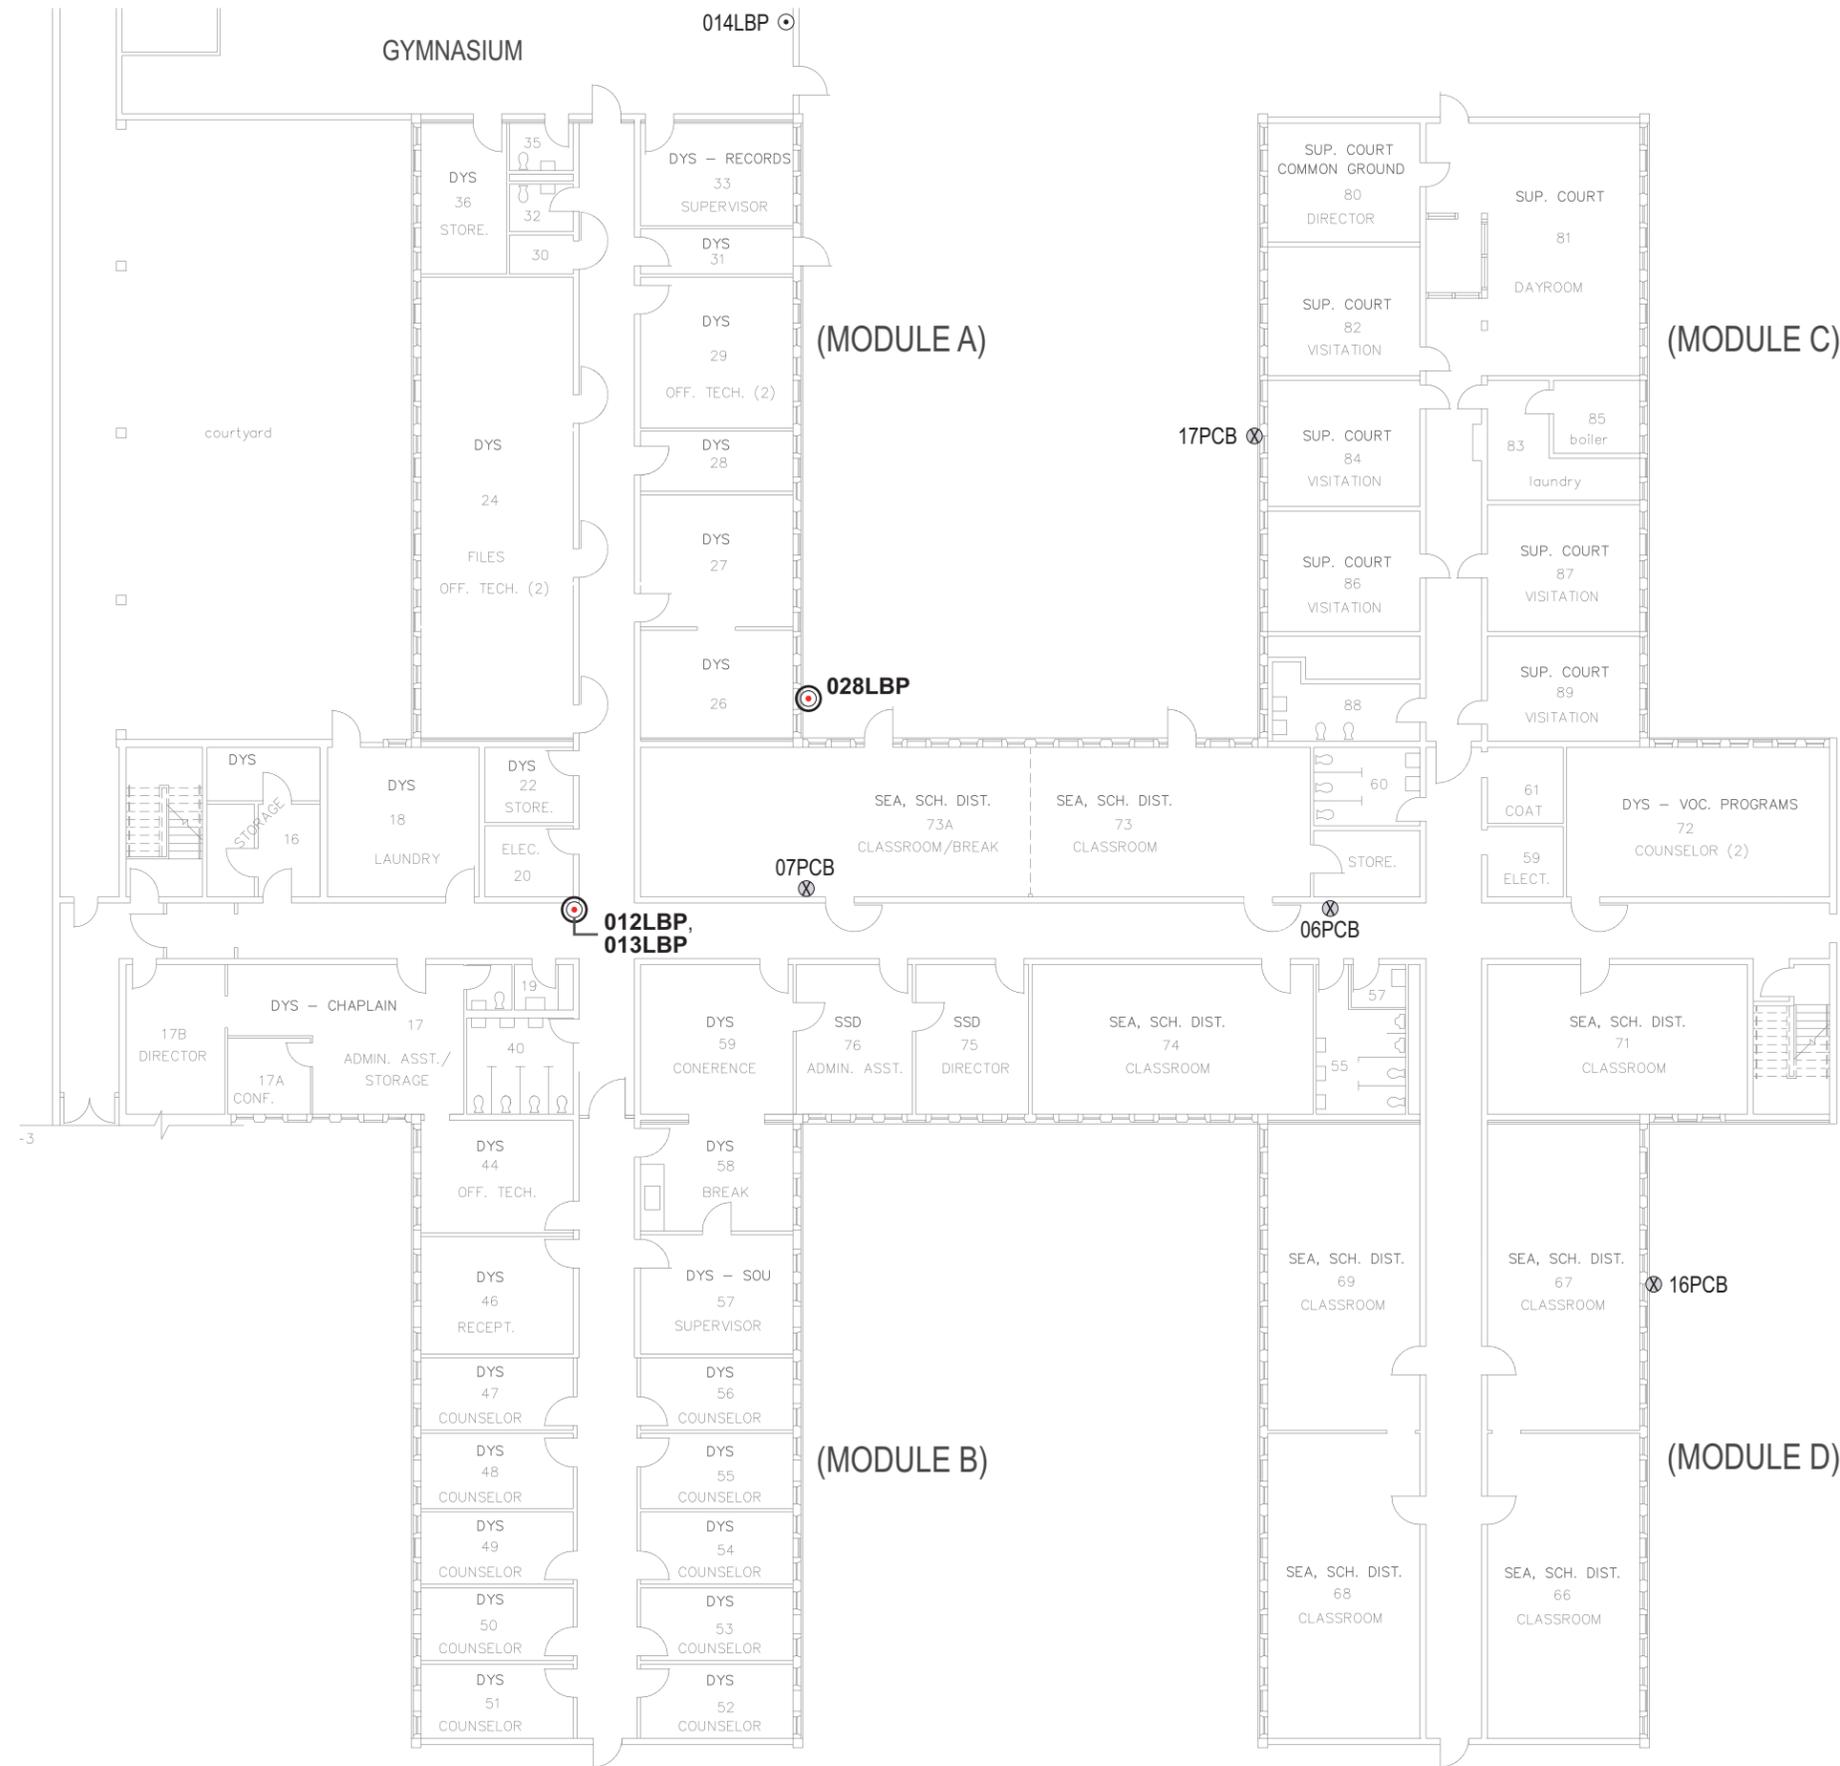
**Figure D-12.**  
**Alder Wing 1st Floor lead-based paint (LBP) and polychlorinated biphenyl (PCB) sampling location map, Youth Services Center, Seattle, Washington.**
