Green River Pump Operations Procedures Plan

Green River Basin Program
serving Auburn, Kent, Renton, Tukwila and King County

PUMP OPERATIONS PROCEDURES PLAN

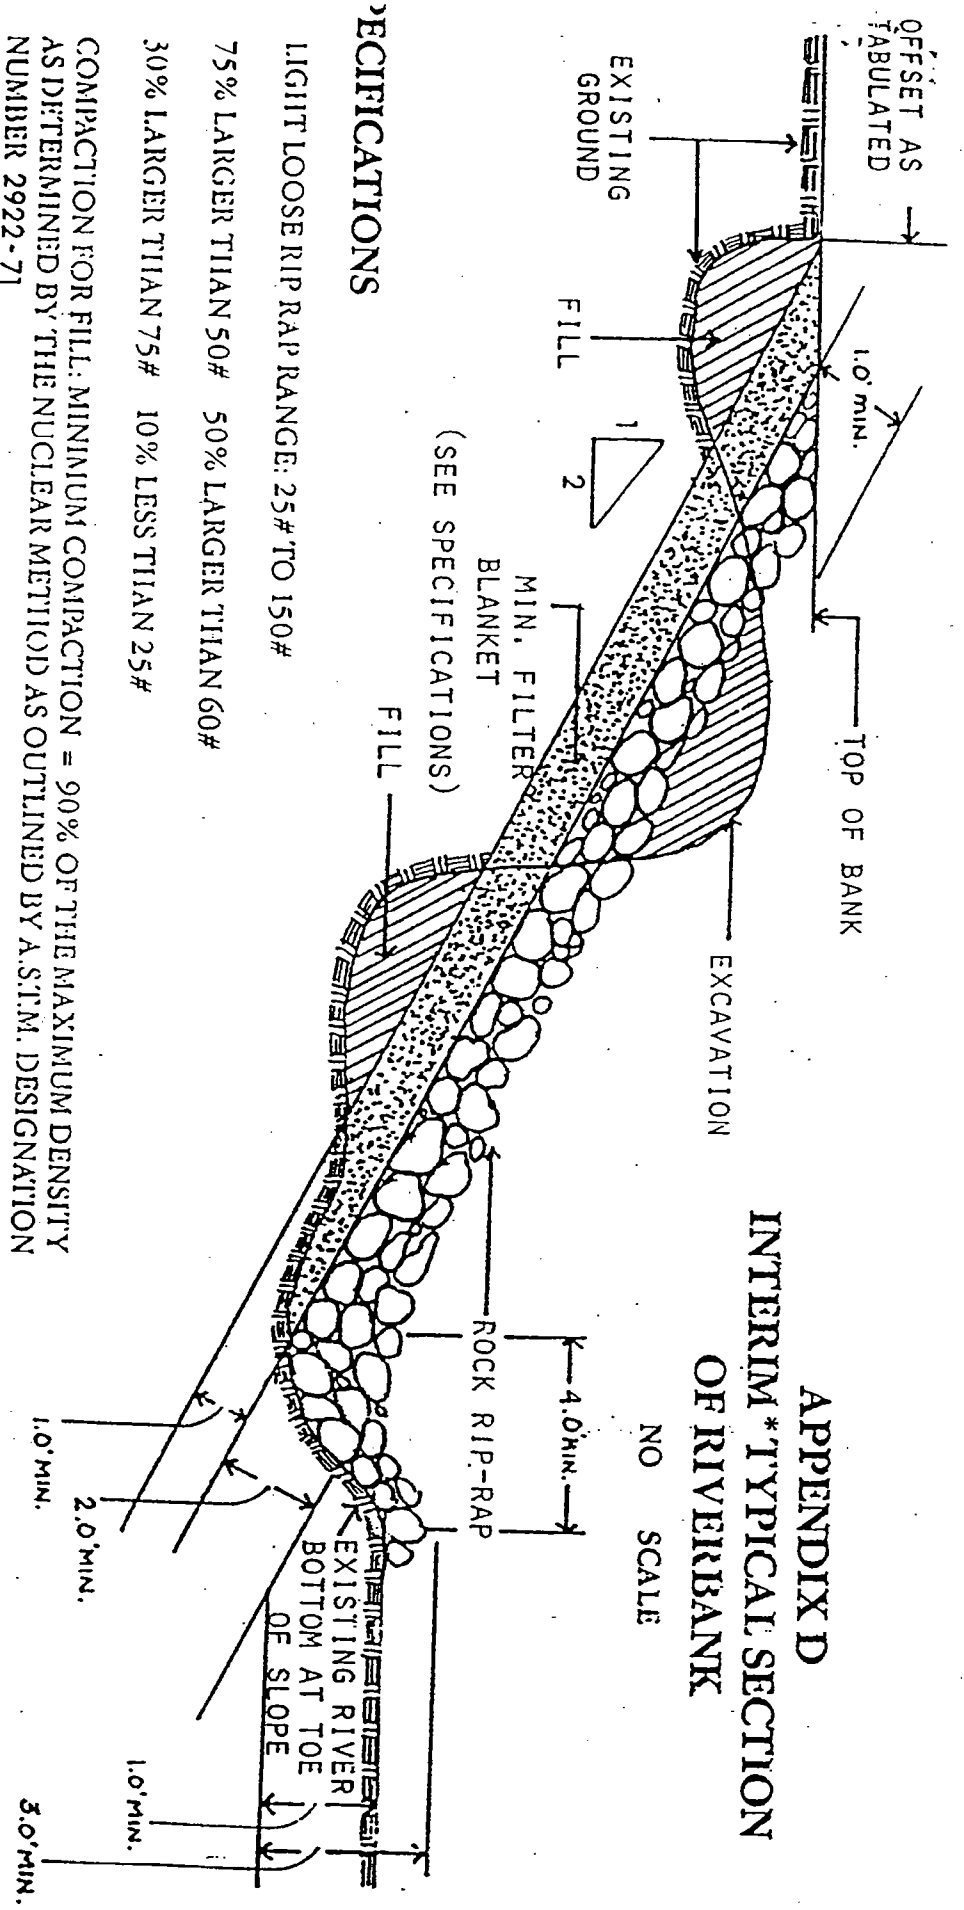
Interim Typical Cross-Section

APPENDIX D
 INTERIM * TYPICAL SECTION
 OF RIVERBANK
 NO SCALE

SPECIFICATIONS

LIGHT LOOSE RIP RAP RANGE: 25# TO 150#
